# The Mill of Benholm

## Conservation Plan

Document version

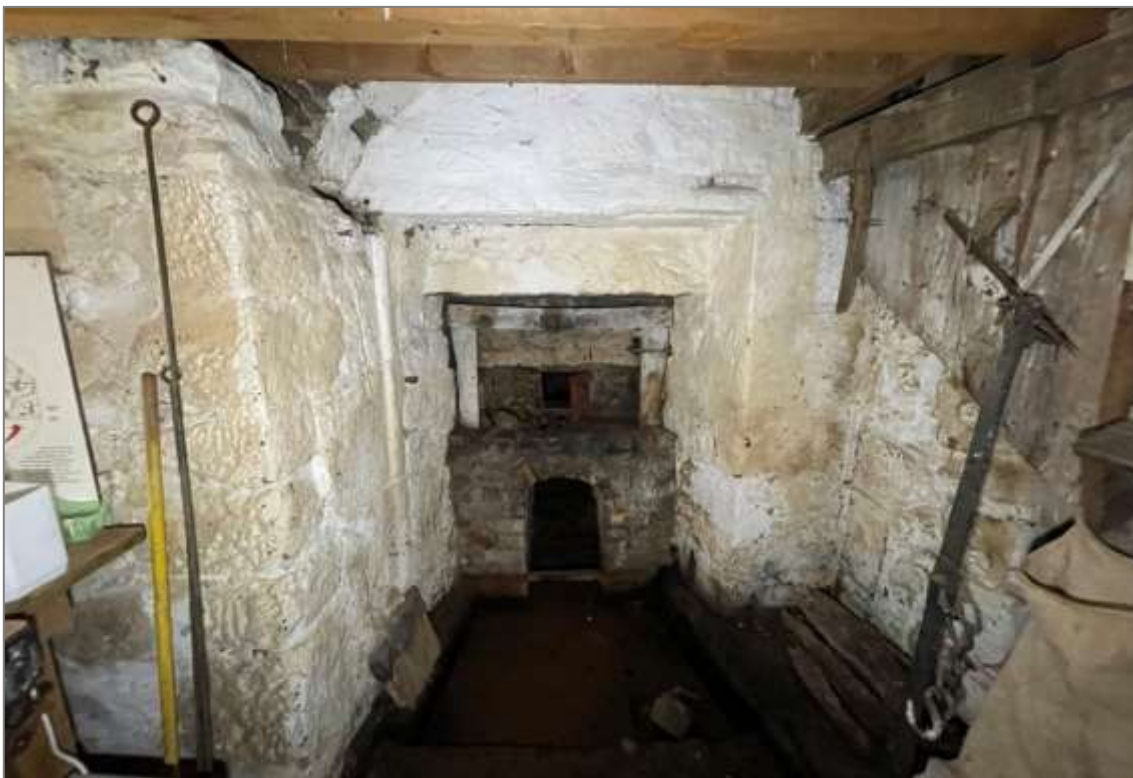
*Mill of Benholm, meal mill kiln firebox on the lower floor. Note the deep wall construction part of which is thought to be an earlier doorway. Staining (damp) on paintwork around kiln opening.*

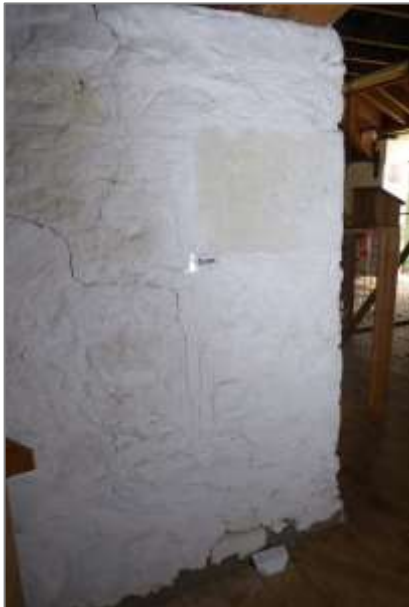
*Meal mill: diagonal separation cracking where the earlier mill building wall meets the southern extension walls*

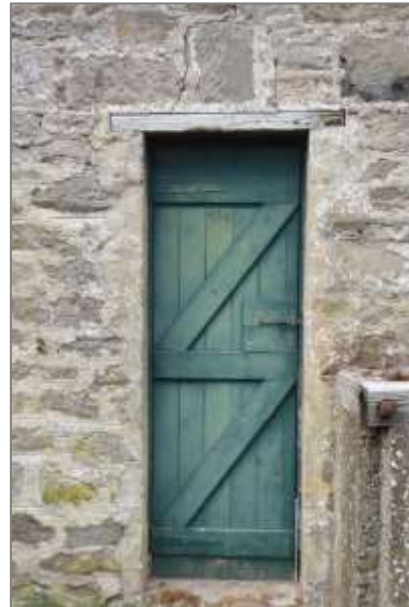
*Meal mill: decayed timber lintol over later internal doorway now forming part of the external wall of the extension*

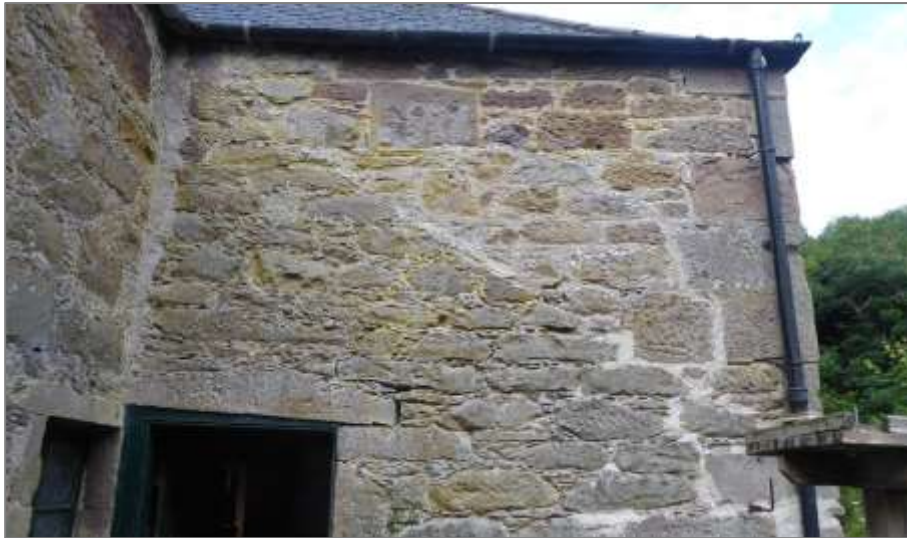
*Meal mill: west elevation of the southern extension showing mortar repair patching at internal corner, open joints to the quoins, and settlement of the stone door lintol.*

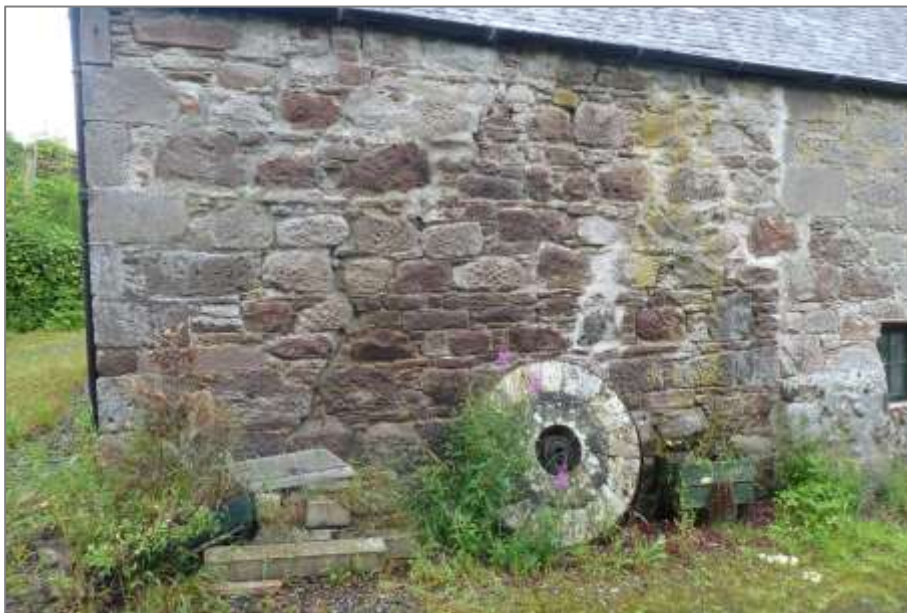
*Meal mill: kiln south elevation showing poorly patched diagonal cracks, possibly as a result of movement*

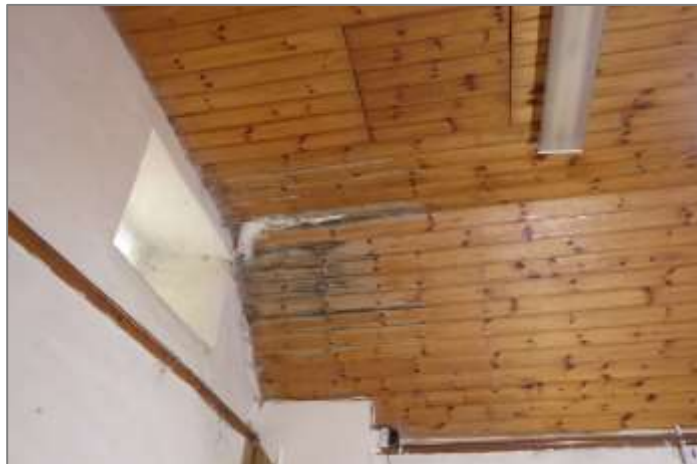
*Miller's house: water ingress at roof level causing damage and fungal growth*

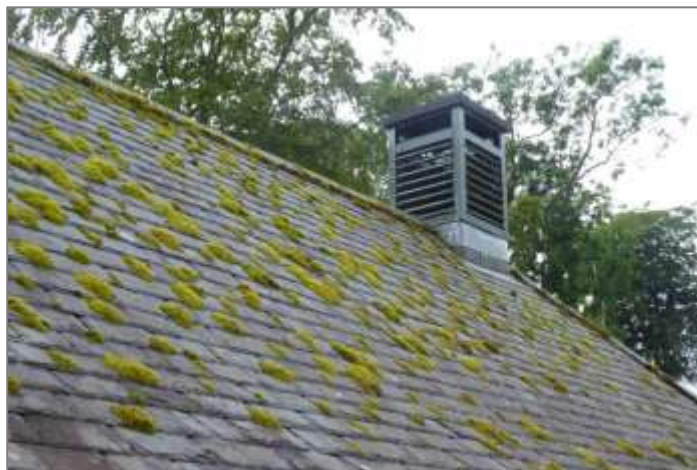
*Meal mill: north roof pitch has a heavy moss build up. Note the inappropriate design of the current ventilator.*

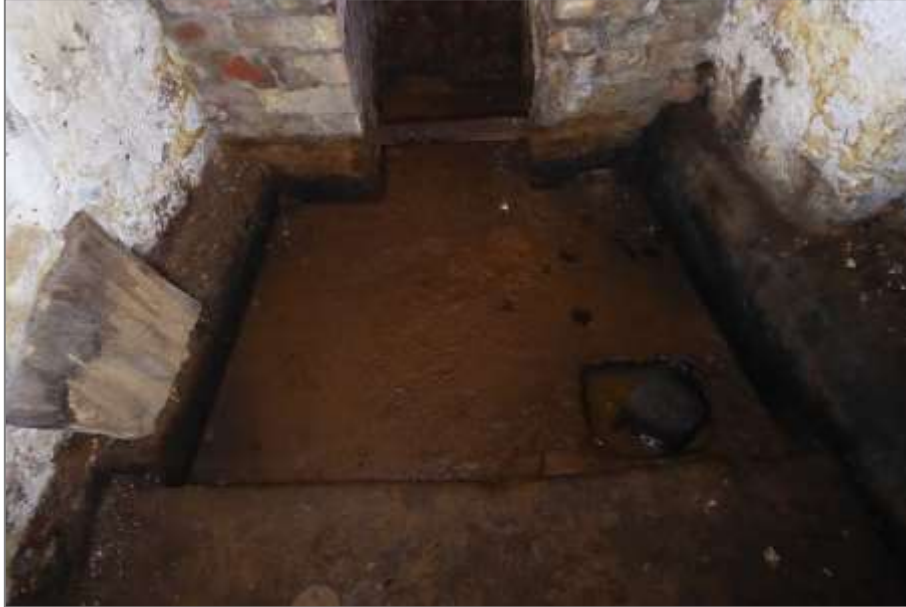
*Ash pit in front of the kiln fire box showing silt build up from repeated water ingress and water sitting in a lowered area, possibly a blocked drain.*

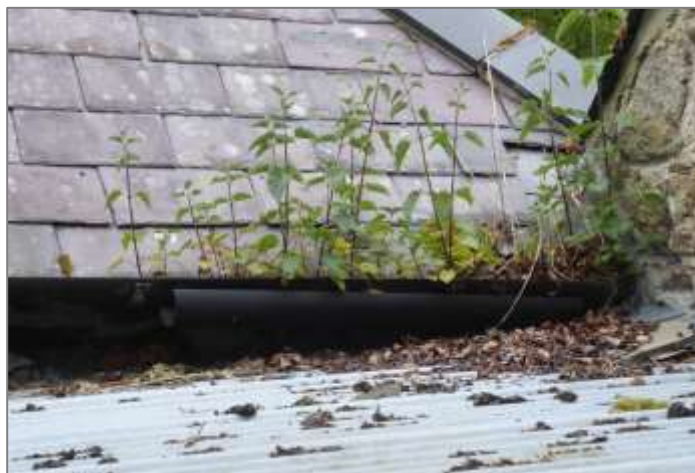
*Detail of the defective junction of the kitchen extension roof and the shop wall; the gutter is blocked and a temporary section of gutter appears to have been placed below the existing gutter.*

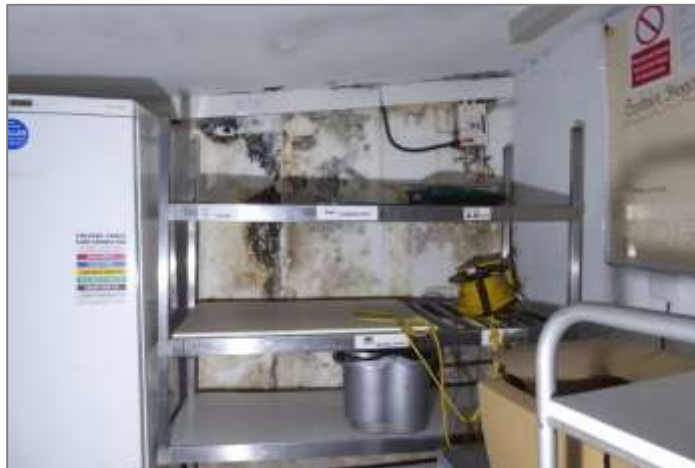
*Below this gutter in the kitchen extension this wall is damp and covered in mould, including adjacent to the electrical distribution board.*

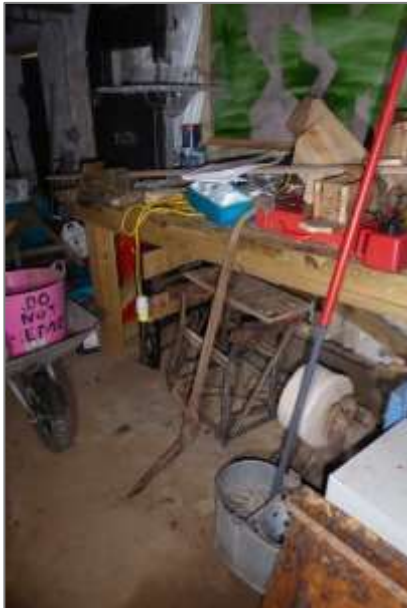
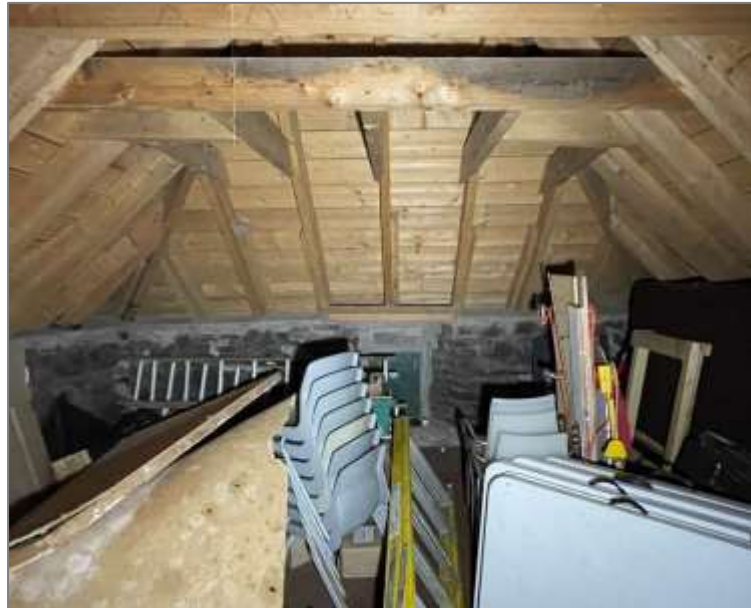
*(right) Miscellaneous items in the lower floor of the meal mill, some may have significance as mill items, others useful for future owners but modern items should be stored elsewhere. (left) Inappropriate storage of items on the kiln metal floor.*

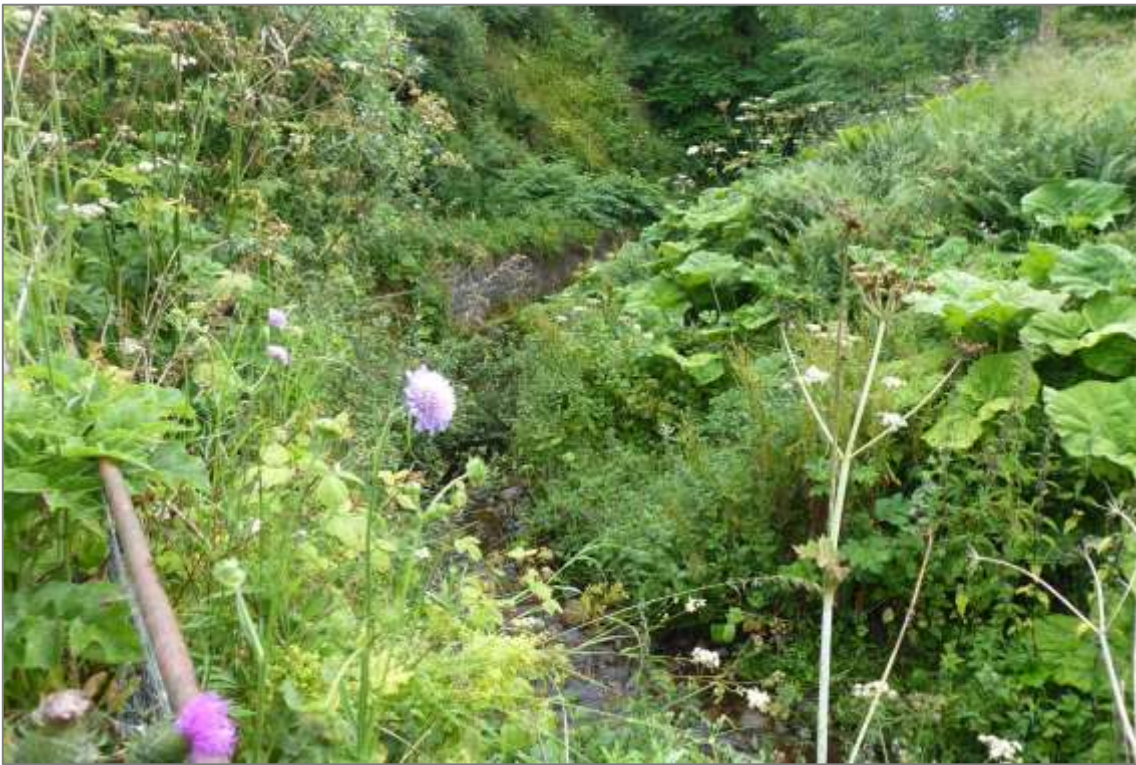
*The Burn of Benholm at the high of summer with vegetation almost completely obscuring the burn retaining wall; inspection and grounds maintenance required during winter session to form repair strategy.*

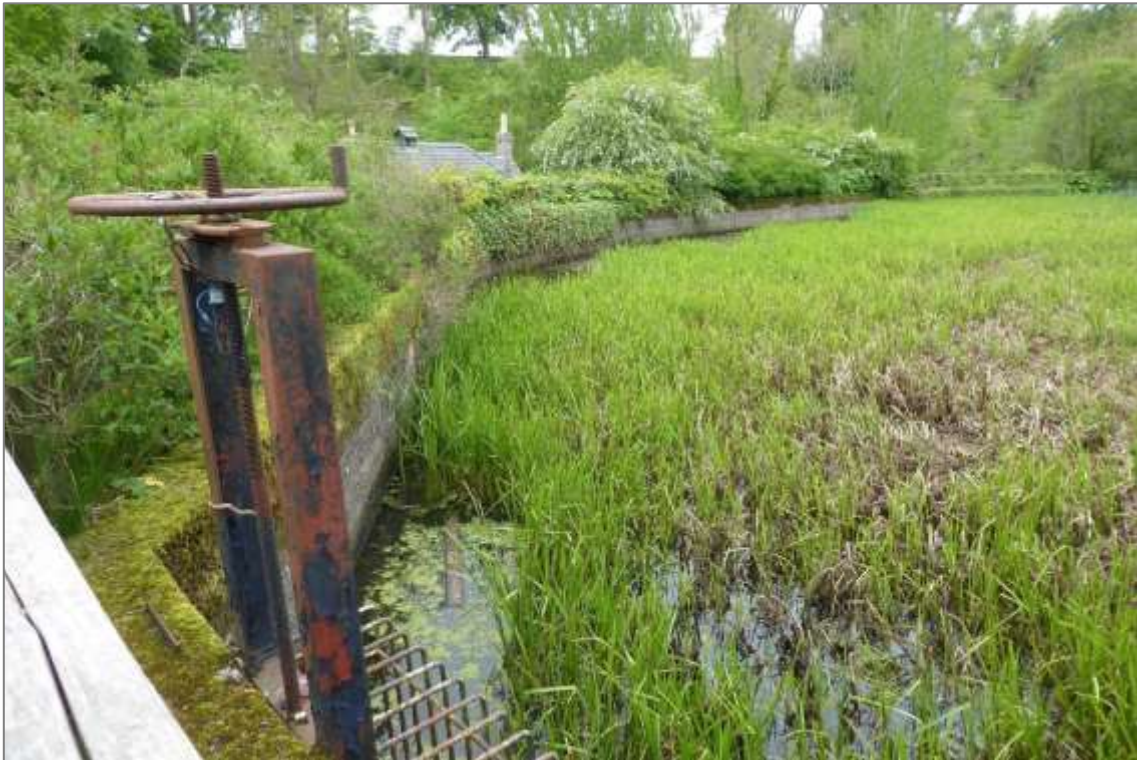
*View of the mill pond in early summer 2023, note the low water level exposing the concrete retaining wall and rusting sluice. The pond is heavily overgrown with vegetation.*
