## Mill of Benholm, Kincardineshire, Aberdeenshire

**Gazetteer: Part 1: Mill Buildings**

# Version 2 November 2023

Prepared by Sonya Linskaill RIAS RIBA  
[slinskaill@btinternet.com](mailto:slinskaill@btinternet.com)

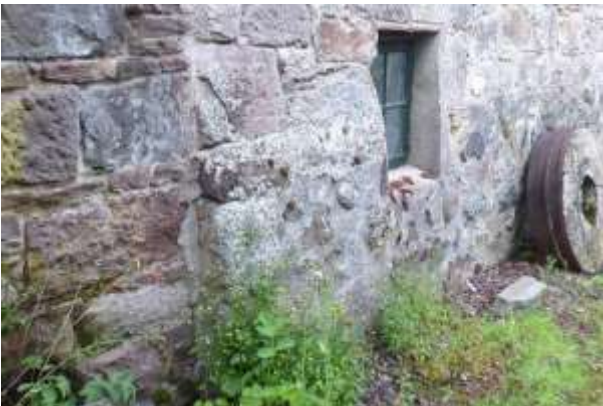
<p>Timber louvered ventilator over kiln with flat roof. Masonry construction indicates further building phases / historic development (described below). Timber fixed pane glazing in a number of fenestration patterns. Timber braced and vertically boarded doors.</p>	<p>As an example of a traditional water-powered meal mill, Benholm is of high significance, being one of only seven grain mills known to be operable or with the potential to demonstrate the milling process in Scotland. Refer conservation plan section 8.3.</p> <p>Evidence of possibly 4 building phases.</p>

The current roof form appears from records to be as the original, however the Welsh slate finish and ridges are not. The ventilator is of an inappropriate design and is discussed further in section 7.3.1 of the conservation plan.

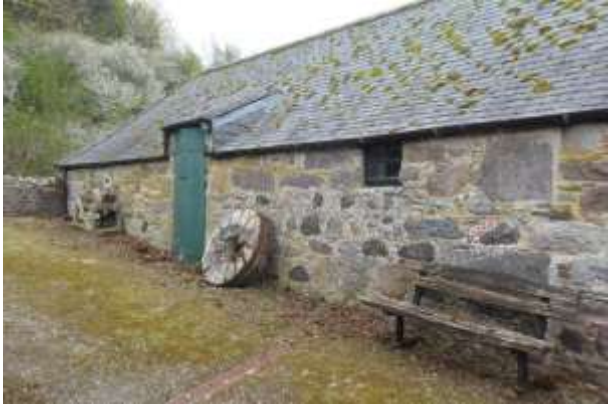
<p>Roughly coursed masonry with large irregular blocks of mixed sandstone with smaller pinning stones. This differentiates the building from the adjoining kiln (see below).</p>

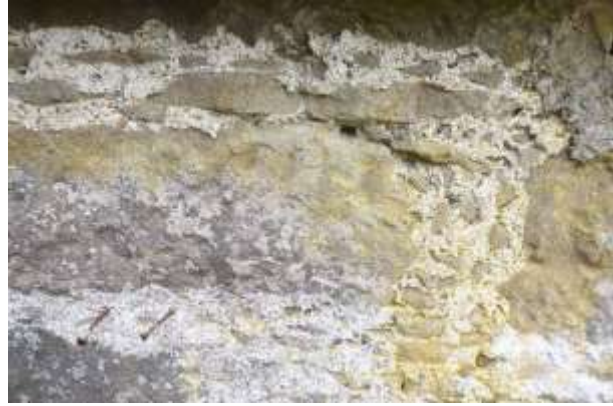
<p>Detail of the small pinning stones in lime mortar, sometimes referred to a 'cherry caulking'. This is a distinctive feature of the meal mill on the masonry which likely dates to the early 19<sup>th</sup> century rebuild and extension.</p>	<p>The cherry caulking and original lime mortars are of high significance.</p>
<p><b>Meal Mill (south elevation)</b></p>

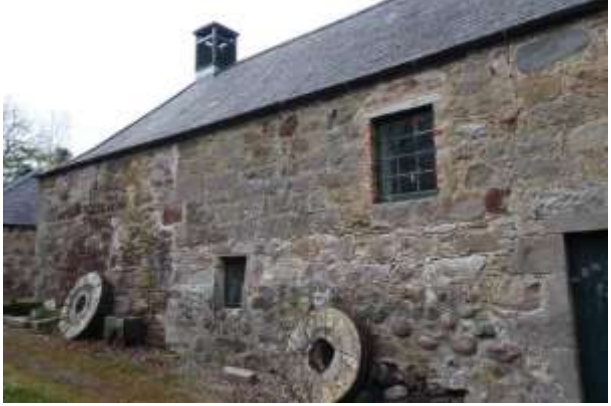
<p>The lowest masonry (c.1m high) of the meal mill's south elevation represents the earliest construction using uncoursed rubble comprising field stones. This suggests that the current building has been constructed on the remains of an earlier mill building or structure either before or in 1817 (see door lintel below).</p>

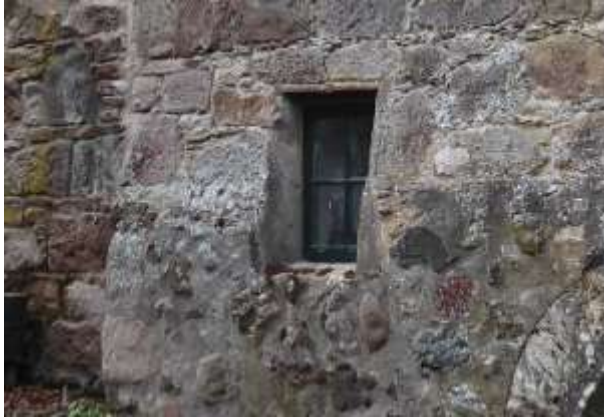
Small 4-pane fixed glass window with lintel formed by iron bar suggesting the window is a later alteration.

Small window previously had 6 panes with horizontal emphasis; the large window was previously a hoist opening for sacks with boarded shutter / door (refer Canmore image B68973 above).  
The openings are of medium significance reflecting development of the functions of the mill.  
The glazed timber windows date to the visitor centre adaptation and are not significant.

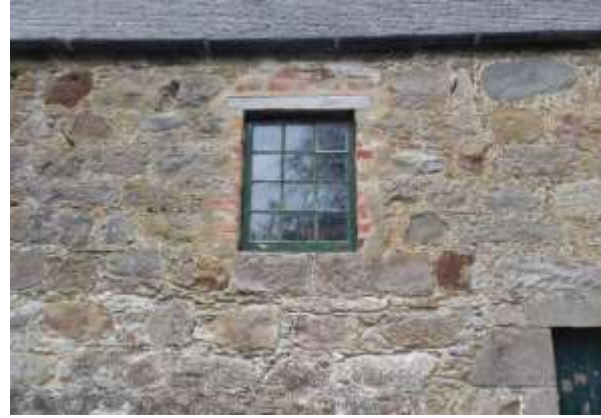
The upper section of the south elevation is coursed rubble of generally pale pink-grey sandstone using roughly squared blocks with the same small pinning stone detail found on the north elevation.  
Large 12-pane fixed glass window with timber lintels and brick jambs, again indicating this is a later alteration.

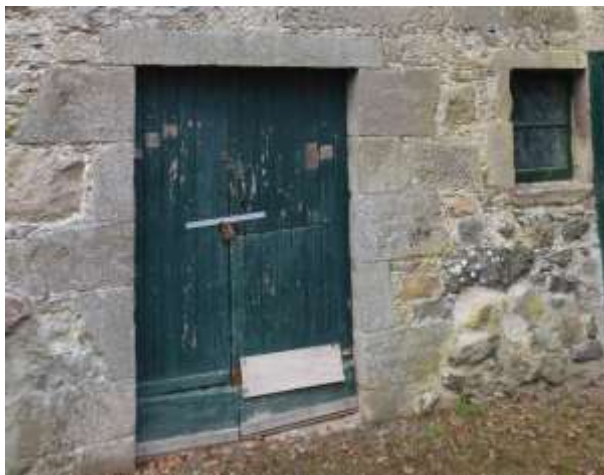
Principal entrance on the south elevation with double vertically boarded doors; the lintel is inscribed "William Davidson 1817" with inscribed initials on the adjoining stones. Small 4-pane fixed glass window to RHS with stone lintel.

The stone entrance surround and inscribed lintel are of high significance as is the timber door. Whilst the connection with William Davidson and the identities of the carved initials has not yet been made, conservation of these details is very important.

The window opening is of medium significance reflecting development of the functions of the mill, possibly on or before 1817.

The glazed timber window dates to the visitor centre adaptation and is not significant.

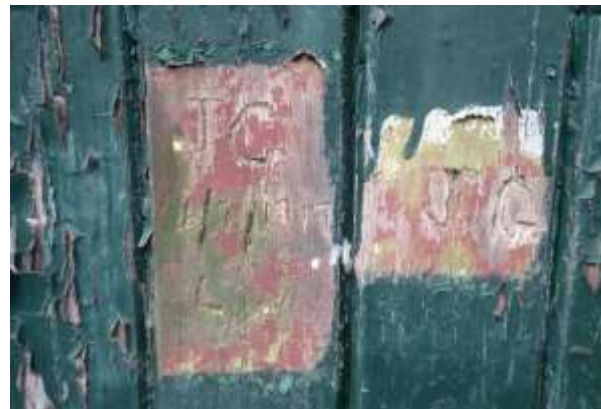
Carved graffiti on timber double doors "JC 6/2/1917 LW" and "JG "(or JC?)

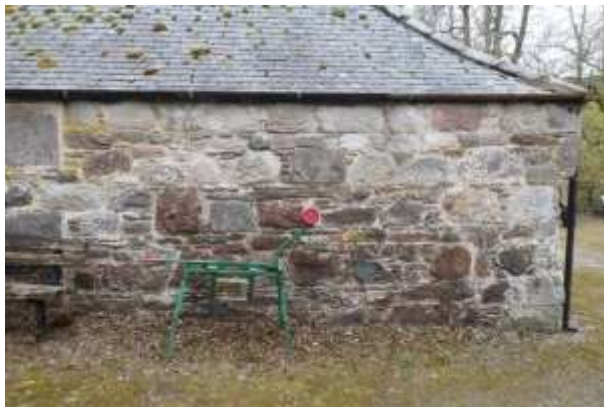
Coursed rubble of mixed sandstone (pale pink-grey /purple-grey/red) using roughly squared blocks with larger pinning stones. Some stugged texture still evident on paler coloured stones (reused possibly from the former circular kiln). Dressed and squared quoins, those on lower NW corner appear damaged / lost probably due to mechanical damage.

The kiln is of high significance reflecting the development of local agriculture and the need for improved grain drying capacity. The masonry has undergone some repair and replacement but remains of high significance in the chronology of the meal mill's historic development.

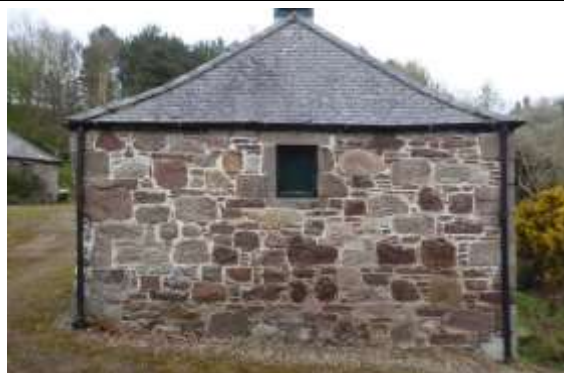
Opening in west elevation from kiln drying room; vertically boarded timber shutter. Possibly an original hoist opening.

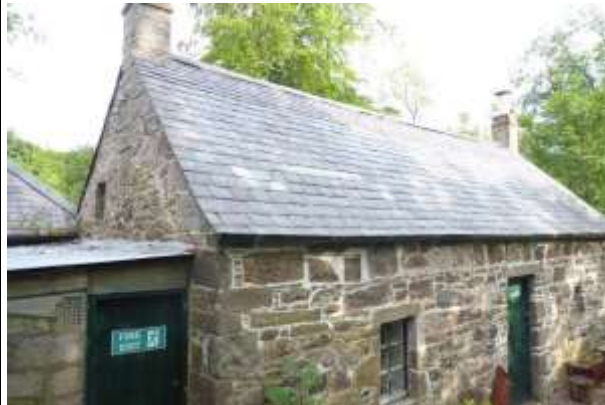
Probable raising of the wallhead seen on the rear elevation and also north facing gable where there is a protruding outline of an earlier lower and steeper gable slope.

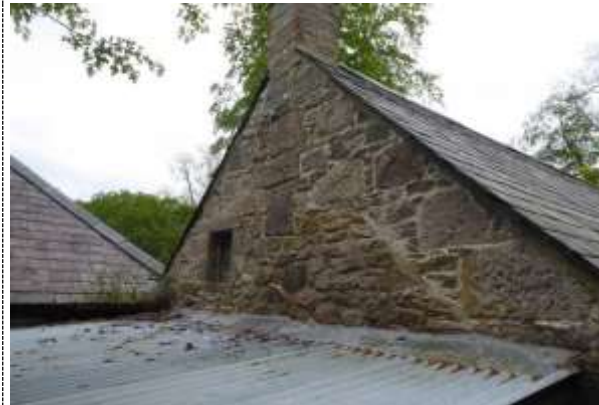
The height of the earlier gable may have been reduced whilst rebuilding to accommodate the large wallhead stones now evident.

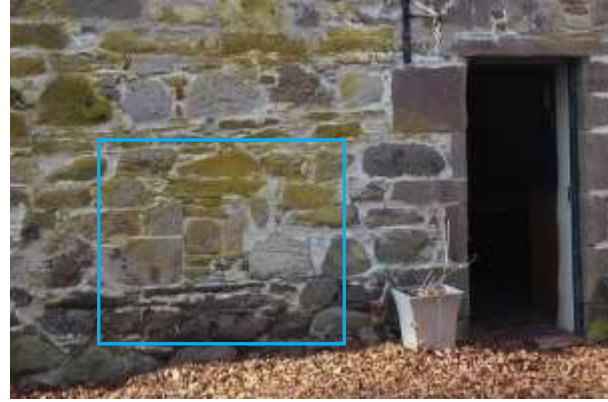
<p>Limewash on a stone above the entrance. This may date from when the wall was enclosed, or earlier external finish protected in the hollows of the stone texture.</p>	<p>What may be the remains of a very small low window are located to the south of the current door.</p>	<p>Very little interior features appear to remain excepting the openings and fireplace. The roof structure is believed to be new (not seen).</p> <p>Further information on earlier forms of the building may be gleaned during any future works to remove modern paint finishes and if the concrete floor were replaced.</p>

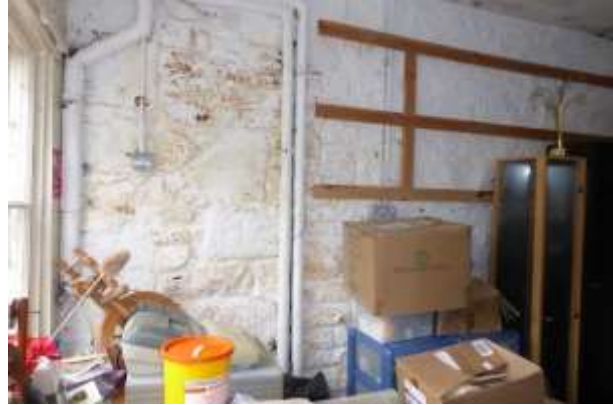
<p>Internal view of the wall shared with the kitchen extension which is very damp from a defect in the extension roof.</p>	<p><i>The interior space could not be inspected due to stored items and levels of mould.</i></p> <p>The barn door and mechanism are of medium significance as a traditional farm building element and should be retained.</p>
<p><b>Byre (toilets)</b></p>

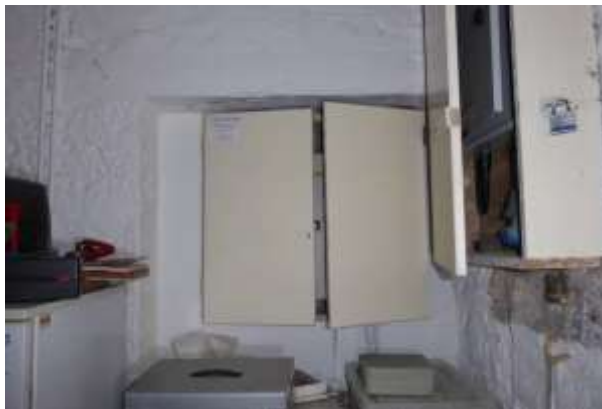
Original side entrance doorway within the byre now infilled with painted timber lintel.

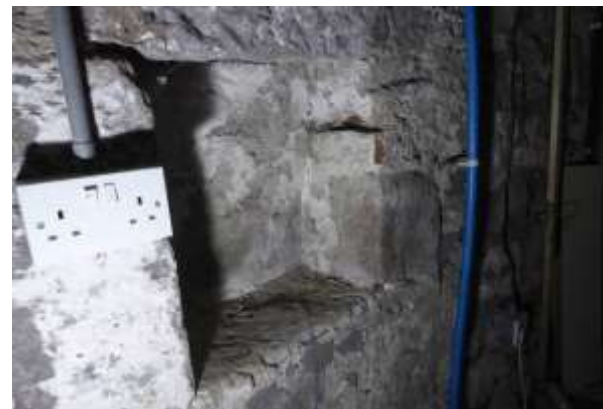
Two recessed openings on either side of the byre door may have been former openings but don't appear in the stonework externally.

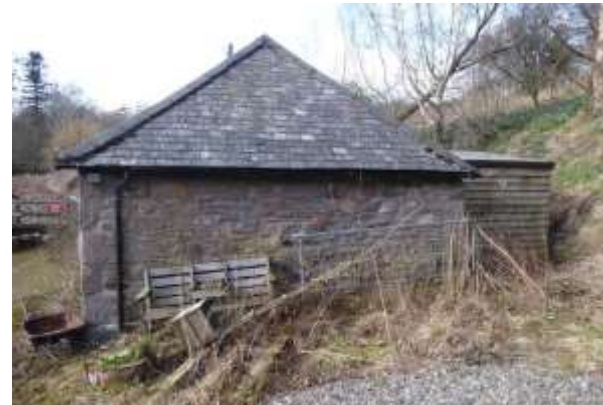
General view of the side (east) elevation where cement mortar pointing from its adaptation is visible.
