Mill of Benholm, Kincardineshire, Aberdeenshire

Gazetteer: Part 2: Meal Mill Lower Floor

Version 2 November 2023

Prepared by Sonya Linskaill RIAS RIBA
slinskaill@btinternet.com

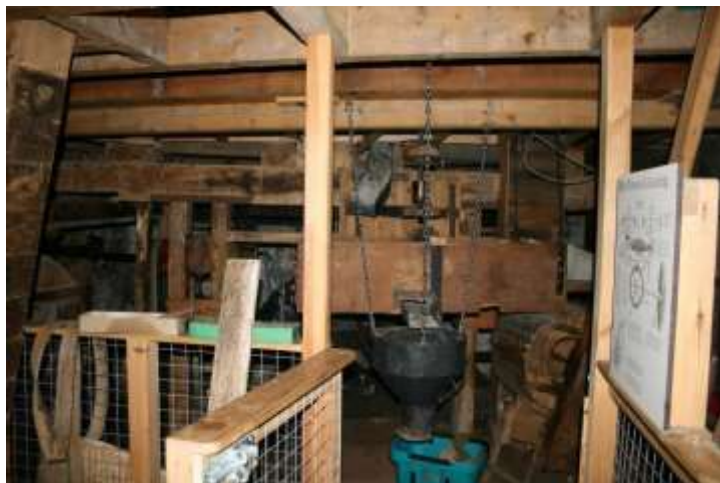
General view looking east toward the gearing enclosure in 2023. The space has a confused appearance with the installation of safety barriers and removal of a substantial part of the earlier **Gear Cupboard** partition.

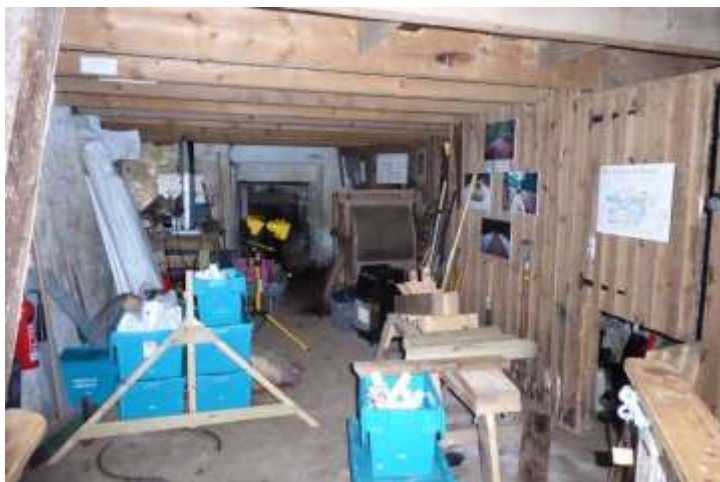
General view looking west toward kiln fire pit in 2023. The space is cluttered by storage of modern items not associated with the mill operations.

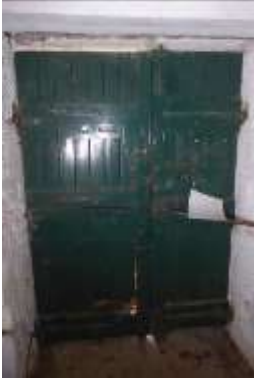
<p>Unevenly sized double doors with cast iron security stay to narrower door leaf (note 1). Damaged lower boarding has been temporarily patched.</p>

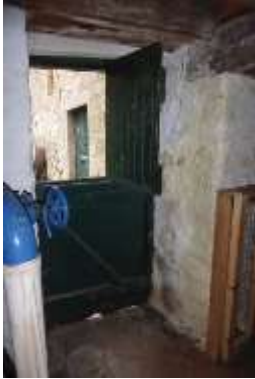
<p>Side entrance comprises a single door split horizontally. Located at abutment of extension to earlier mill building.</p>

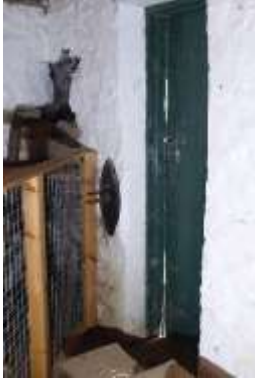
<p>Extension entrance, with door 'back to front' which suggests it was a later intervention to connect to the extended Engine House (removed).</p>	<p>Note 1: Double doors have historic graffiti on external face and are of high significance. Refer Gazetteer Part 1. The other doors are thought to be later in date.</p>
<p>Meal Mill Lower Floor Windows on south elevation</p>

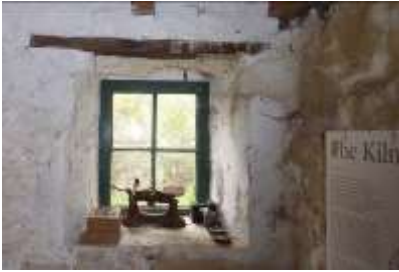
<p>Window at kiln end of earlier building. 4-pane fixed glass window (replacement).</p>

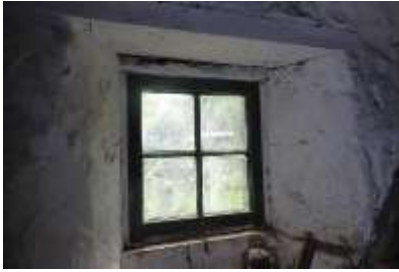
<p>Window at foot of stair. 4-pane fixed glass window (replacement).</p>

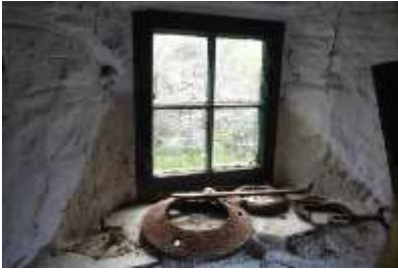
<p>Window in southern extension. 4-pane fixed glass window (replacement).</p>	<p>Small window by kiln previously had 6 panes with horizontal emphasis (refer Gazetteer Part 1). The openings are of medium significance reflecting development of the functions of the mill. The glazed timber windows date to the visitor centre adaptation and are not significant.</p>

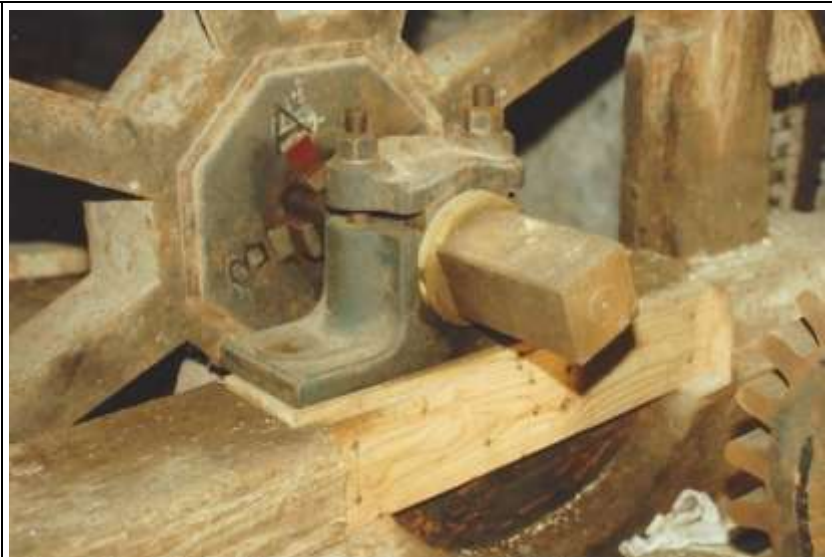
WE Ltd repaired hub on **Auxiliary Spur Wheel** (WE Ltd image).

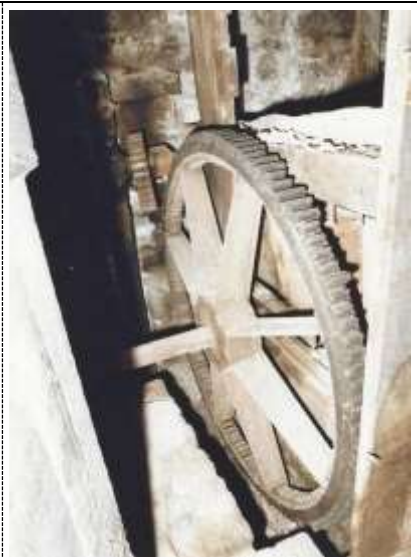
The **Auxiliary Spur Wheel** before restoration, note the worn and damaged wooden teeth (WE Ltd image).

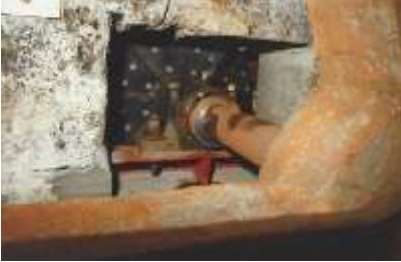
<p>WE Ltd fabricated a new axle which it fitted through the external wall to the waterwheel. There is an intermediate bearing on the water wheel shaft where the shaft passes through the wall. (Note 2)</p>

<p>View of the gear cupboard in 2023.</p>	<p>Note 2: The original intermediate bearing support had been patched over the years. To improve support and restraint for the waterwheel WE Ltd enlarged the hole, added a steel bed plate to provide firm support for the plummer block with cement consolidation of existing wall.</p>

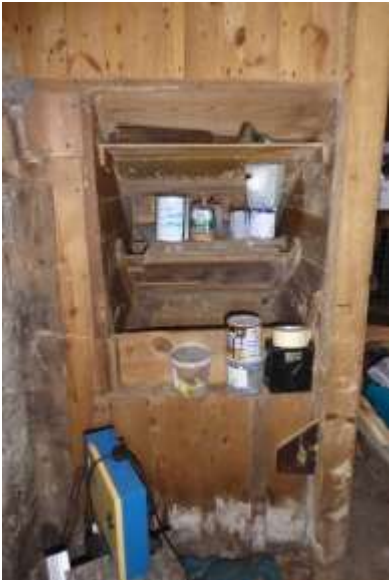
<p>West end of the Large Fanner with second hopper for unshelled oats, currently inappropriately used for storage.</p>

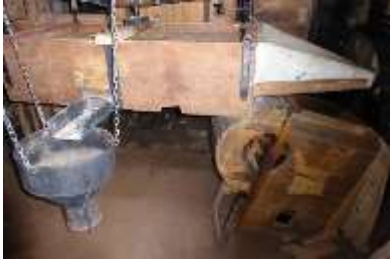
<p>Meal Sieve with metal chute at southern end over Small Fanner below. Metal spout at base of sieve projecting over funnel (presumably for bagging oatmeal).</p>

<p>Detail of metal spout through floor from Grinding Stones above to discharge onto the Meal Sieve, with crank shaft behind.</p>	<p>Used to separate oatmeal from unground groats and small husks from the grinding stones. A metal spout from the tun above deposits them onto a series of 4no. wire mesh sieves suspended from the ceiling above. The sieves sit into a wooden box, and are shaken by a crank shaft via a belt drive from the mill spindle. Oatmeal will fall through the sieves (which are used to grade the oatmeal) to a metal spout at the base of the box; a metal bagging funnel is suspended from the ceiling. Groats and large particles of meal travel to the end of the sieves and are fed into a small fanner via a large metal trough. They fall to the bottom of the fanner and from there are fed into the continuous-flow bucket elevator for the grinding stones which deposits them into the stones for a second time. Air flow pushes husks out of the end of the Small Fanner where they are bagged. Small fanner damaged including broken leg.</p>

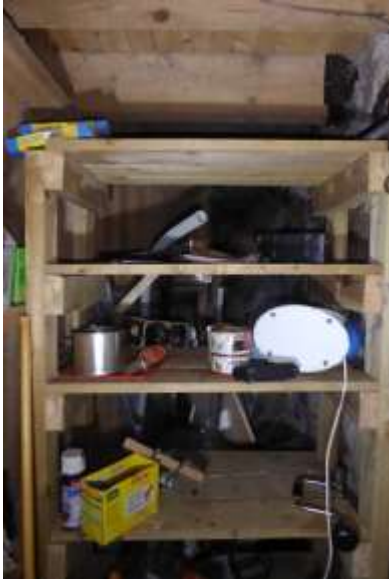
<p>View into the Husk Cupboard looking west – disused / storage.</p>	<p>“Shell Cupboard” (recorded by Douglas (Canmore, 1983, MS/500/35/83). Considered to be an original feature of the mill although storage of items inside and against the cupboard make assessment of original material difficult. An outlet from this cupboard to the upper floor may have been removed.</p>
<p>Meal Mill Lower Floor Kiln Chute</p>

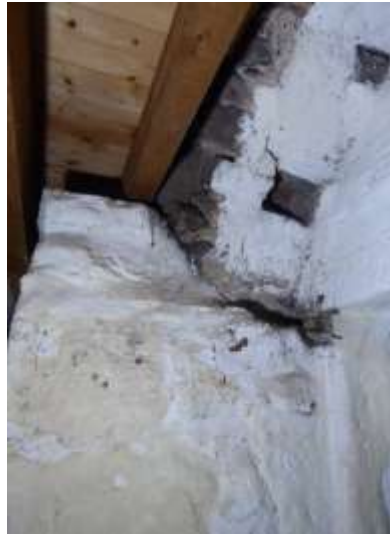
Detail of wall above forming the kiln opening on the south side – possible joist / timber rafter pockets.

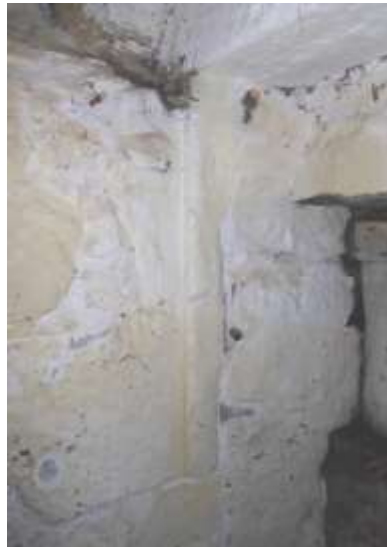
Detail of wall forming the kiln opening on the south side – evidence of dressed stone opening.
