Mill of Benholm, Kincardineshire, Aberdeenshire

Gazetteer: Part 3: Meal Mill Upper Floor & External Items

Version 2 November 2023

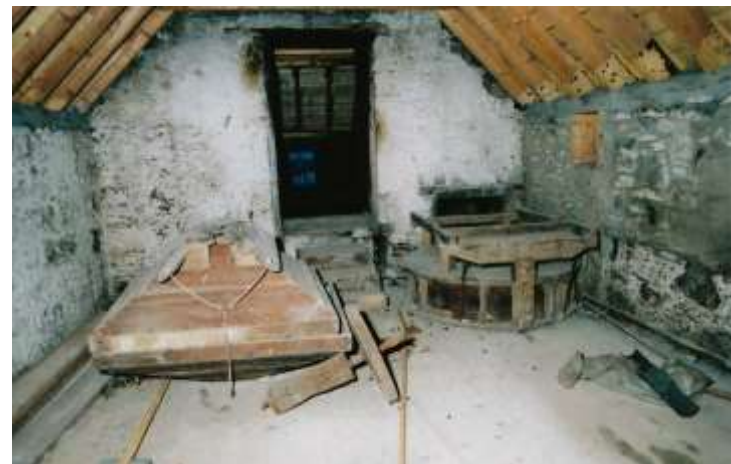
Similar view taken by WE Ltd during the restoration works, c.1991. Note dismantled milling items, repointing of walls with inappropriate cement and new timber rafters.

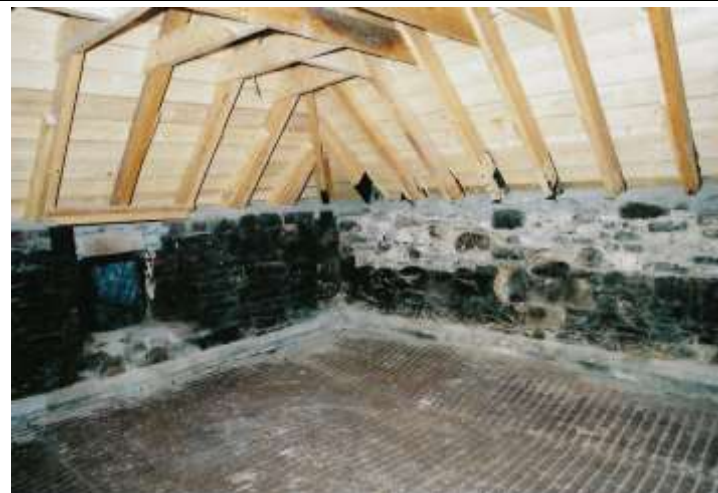
WE Ltd image during the restoration works, c.1991 of the kiln interior. Note repointing/rebuilding of walls with inappropriate cement and new timber roof construction. This floor probably dating to 1971 when a fire destroyed the kiln roof.

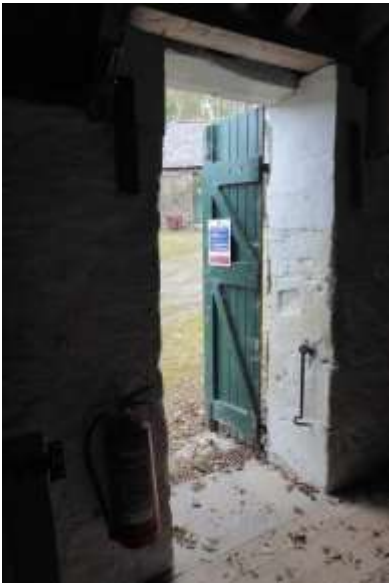
<p>North elevation: braced and boarded double leaf entrance doors. Iron security bar attached internally at jamb. Doors are replacements.</p>

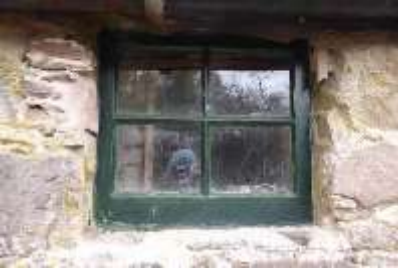
<p>North elevation: 4-pane fixed glass window (replacement). Internal and external openings are out of alignment suggesting it was not originally a 'window' (see note 1).</p>

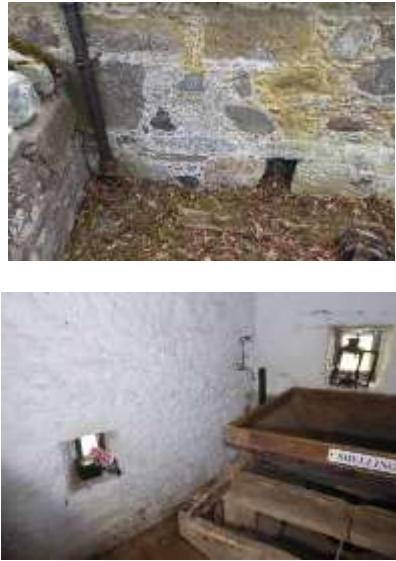
<p>North elevation: small glazed opening said to be used by the miller to see the level of the sluice. Ground levels mean that the cill is at ground level externally and at 530mm internally (see Note 2). Also a former opening or recess in the corner next to the current sluice lever.</p>	<p>Note 1: Possibly item described as "outlet from dust cupboard" in Douglas (1983; Canmore, MS/500/35/83) which is no longer connected to lower floor.</p> <p>Note 2: View inaccessible due to new boundary wall however view to sluice seems unlikely / external ground levels have been raised? This glazed open may have just been the former opening to operate the sluice lever as indicated in Douglas (1983) and Woodward-Nutt (1983).</p>

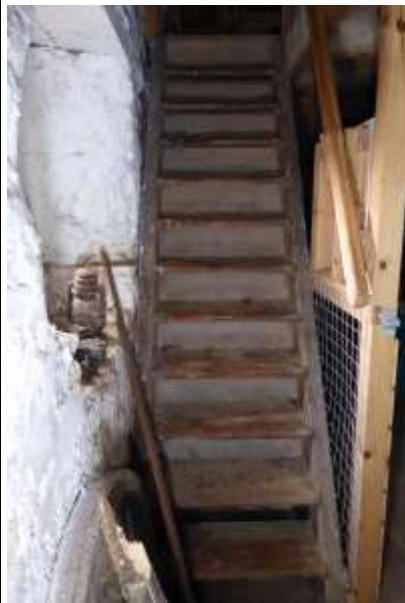
<p>The stair appeared to be enclosed by low timber boarded partitions now removed and replaced by a modern timber and metal mesh screen. (Canmore, 1983, MS/500/35/83).</p>
	<p>View of the timber stair looking from the upper floor.</p>	<p>View of the timber stair looking from the lower floor.</p>	<p>Detail of the timber treads.</p>

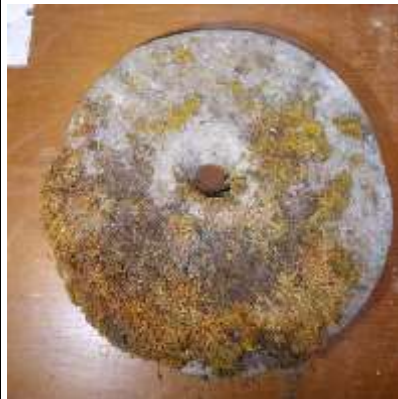
<p>Worn / eroded / moss covered quern stone.</p>

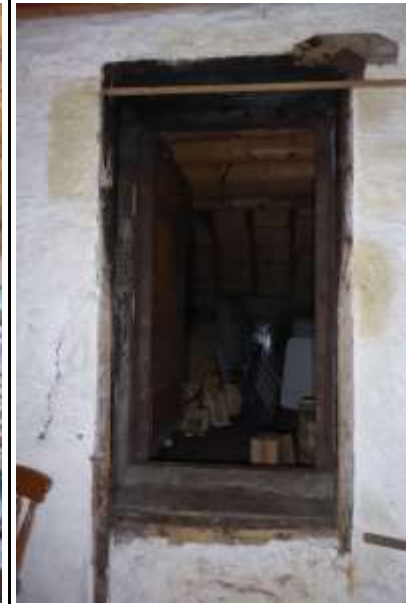
(Above) view from milling room. Large door opening with stone kerb/cill, timber frame flush to internal mill wall and timber lintels (charred). Iron door and door frame set back in line with internal wall of kiln. Wedge wire mesh floor, raised above FFL at c. 500mm. Raised concrete kerb around kiln floor with metal trim. Opening in west external wall with timber boarded hinged cover.

Large amount of miscellaneous items and furniture stored in the kiln which could overload the floor and damage the mesh. Restricted assessment of walls and floor.

Steps up into kiln shown in 1983 (Canmore, MS/500/35/83) have been removed. Timber frame pieces externally could be remains of the former steps up into the kiln.

The kiln door may have been an earlier opening in the gable wall of the earlier mill configuration – large jamb stones and stone cill could suggest this, however also brick infill at jambs. Timber lintels suggest some age.

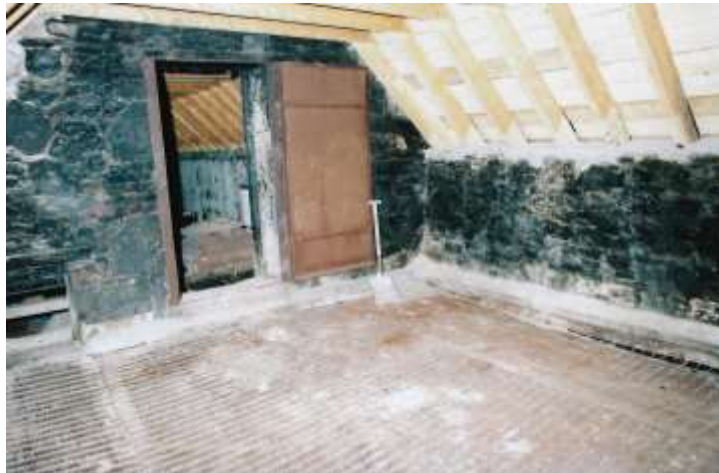
(Left) WE Ltd image during the restoration works, c.1991 of the kiln interior. Note repointing/rebuilding of walls with inappropriate cement and new timber roof construction. This floor probably dating to 1971 when a fire destroyed the kiln roof.
