Mill of Benholm, Kincardineshire, Aberdeenshire

Gazetteer: Part 4: Water Mill Infrastructure

Version 2 November 2023

Part 4: Water Mill Infrastructure

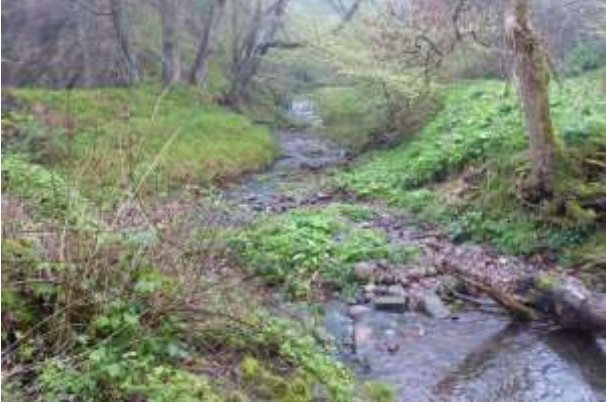
<p>Looking SW from the Lower Weir at the head of the lade to the Burn of Benholm. The Upper Weir is in the distance.</p>	<p>Miller (1996) notes that the efficient operation of the water source (i.e. Castle Burn) also relies on the Aqueduct. However both Whittaker Engineering Ltd. and Pete Babs have confirmed that the aqueduct was not functioning and was not restored as part of the repair works. There appears to have been some dispute at that time as to the ownership of the ground to the west of the burns, said to belong to the manse and access to clear the original underground pipework or to lay over ground pipe was prohibited.</p>
<p>Castle Burn</p>

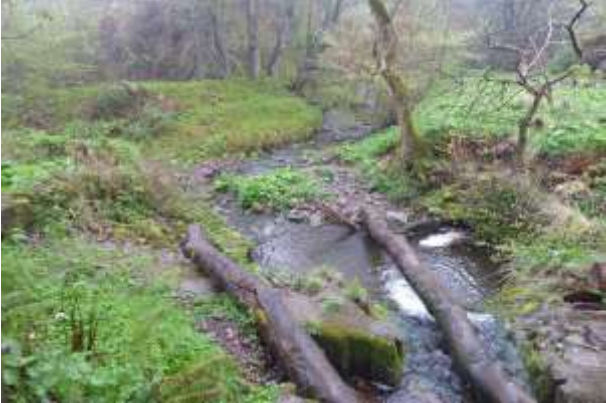
<p>The primary water source for the mill is the Castle Burn seen here looking north from the Lower Weir at the head of the lade.</p>

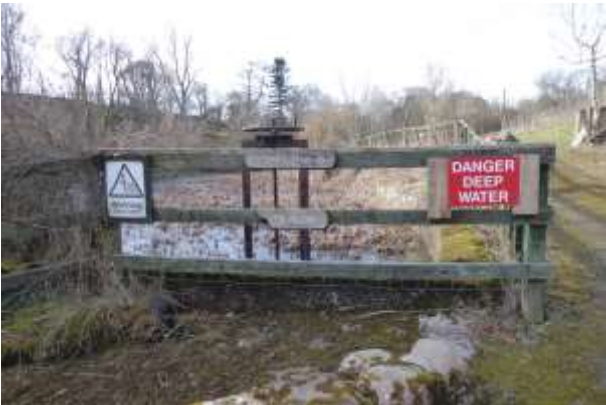
<p>Pond sluice outlet with grille</p>

<p>This sluice releases water from the mill pond via a stone lined culvert under the yard to the Trowse at the head of the Waterwheel.</p>

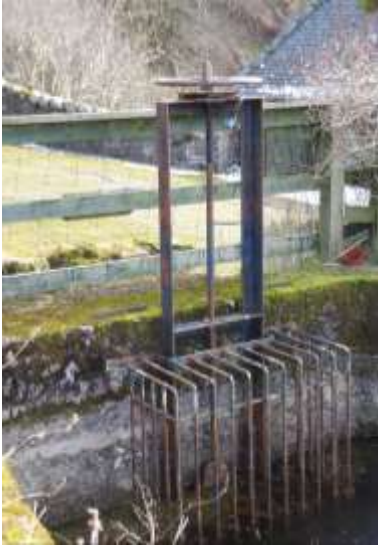
<p>View of the pond sluice grille to prevent debris entering the waterwheel.</p>	
<p>Culvert</p>

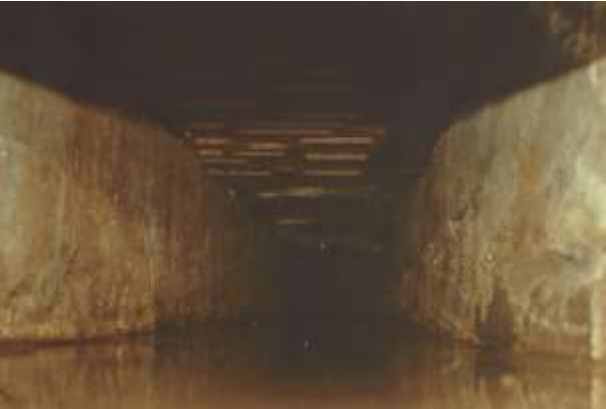
<p>The stone lined culvert was reconstructed by WE Ltd having partially collapsed. The full length of the culvert was exposed, the stone sides rebuilt with concrete base and rebuilt roof with both stone slabs and steel plates below the track. (WE Ltd image).</p>

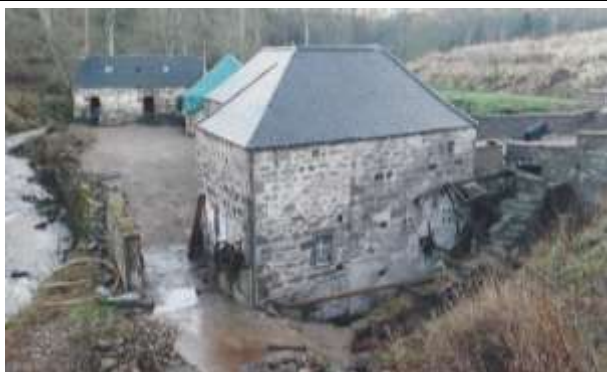
General view c. 1991, note the earlier waterwheel has been removed. (WE Ltd image).

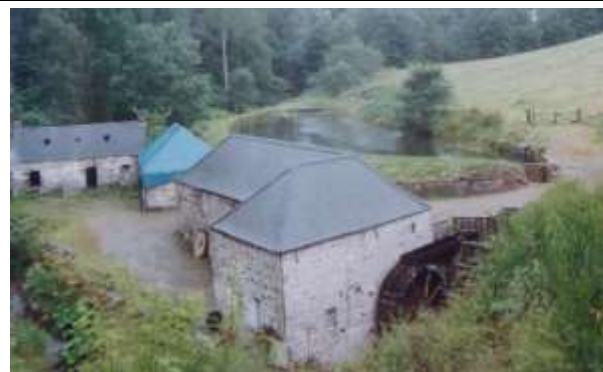
General view shortly after repair and renewal of the waterwheel, with the new **Trowse** clearly visible above the **Waterwheel** and a new higher boundary wall next to the building. (HES file image c.1992).

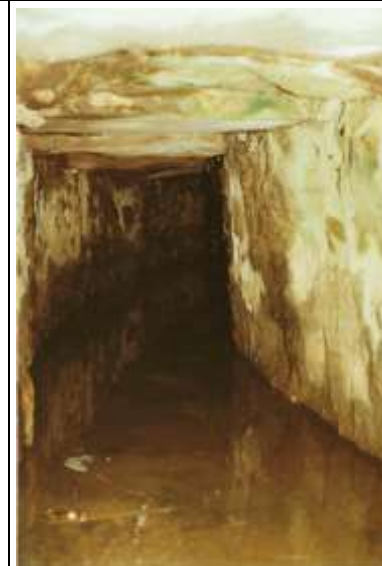
View within the tailrace during the restoration works c. 1991. (WE Ltd image).

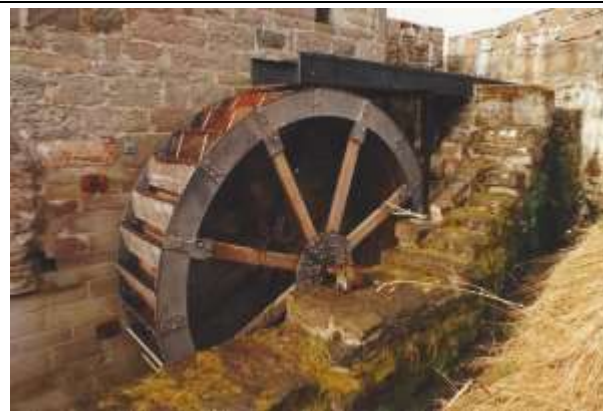
The new waterwheel and trowse shortly after installation (WE Ltd image).
