# The Mill of Benholm

## Conservation Plan

Document version

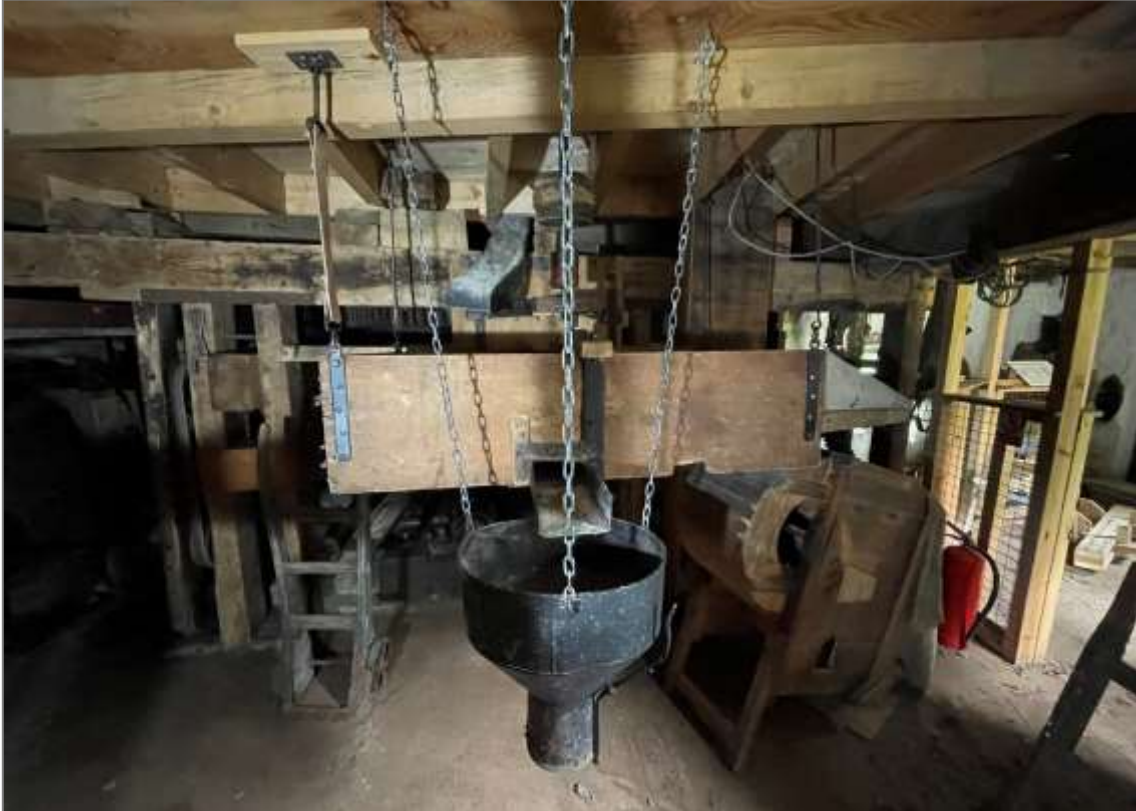
*View of the gearing cupboard in 2023, note the restored Meal Sieve & Small Fanner back in place, however much of the timber walling which formed the gear cupboard has been lost.*

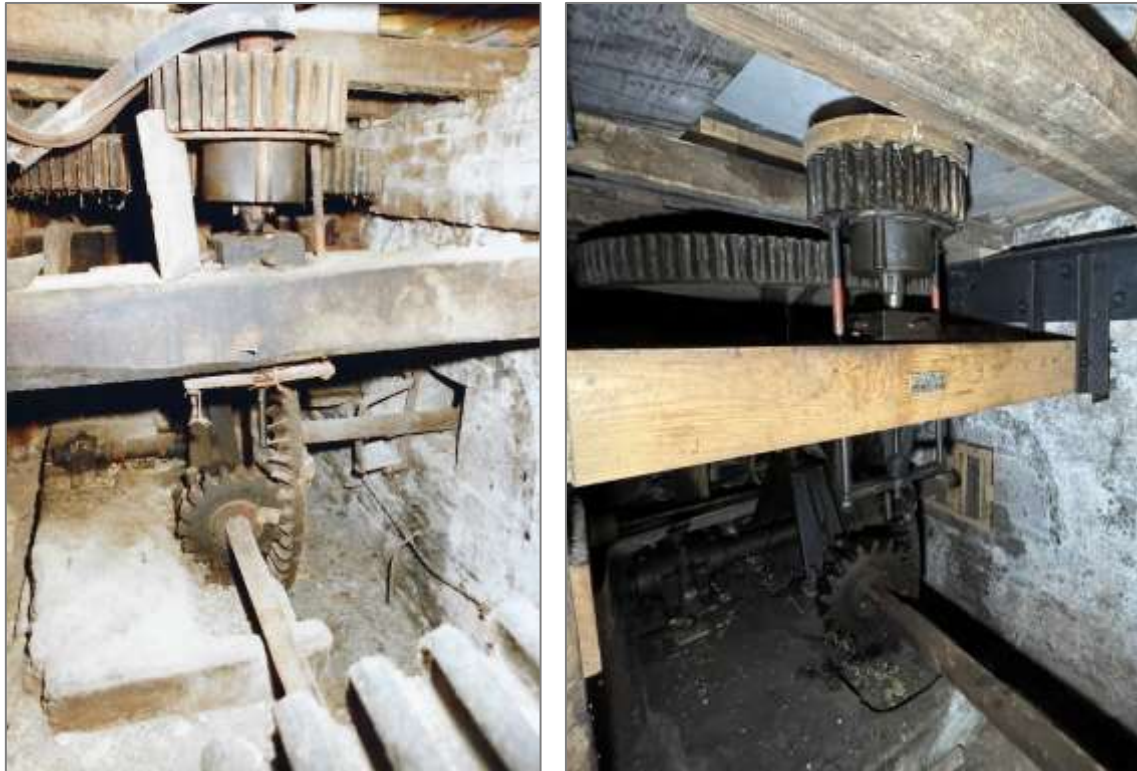
*View of the primary machinery before restoration (left; WE Ltd image c1990-91) and in 2023 with the new bridge tree in the foreground and steelwork added to support the gearing structure and floor joists above.*

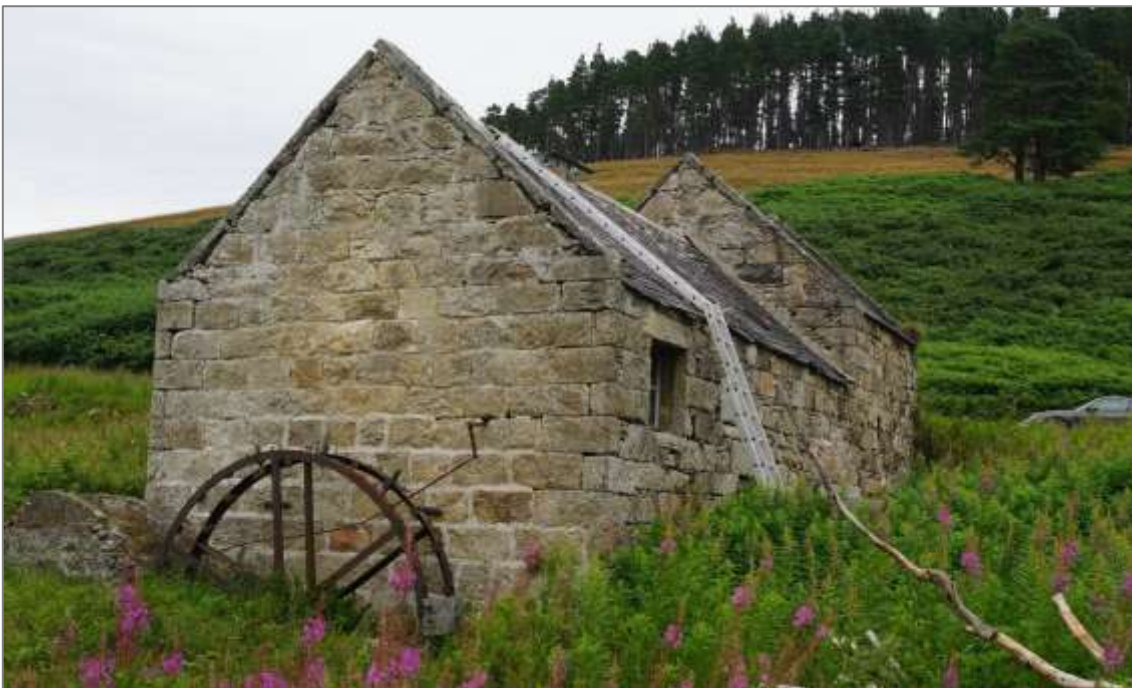
*The Mill of Glenbuchat is an example of a small former estate mill built in 1829 already disused when Hume visited in 1976 but which still survives, now a garage and store and in need of repair, currently on the BARR.*

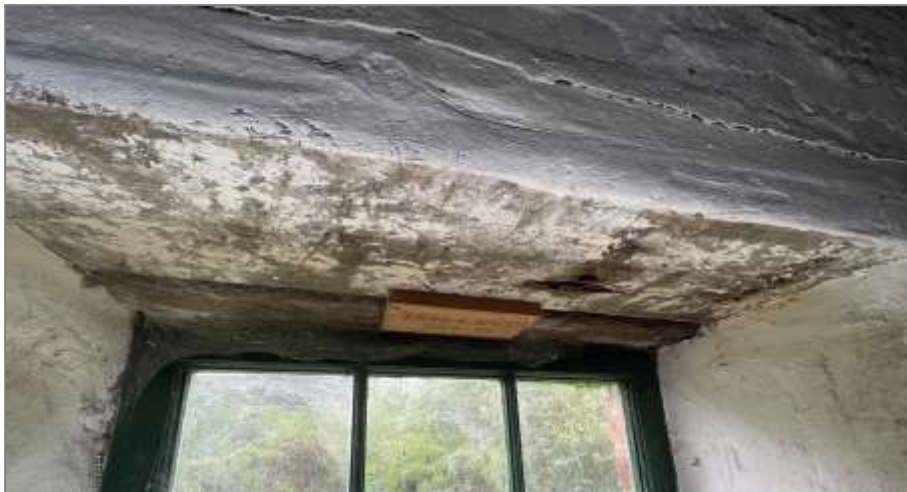
*Meal mill: historic timber lintol over the 12-pane window on south elevation.*

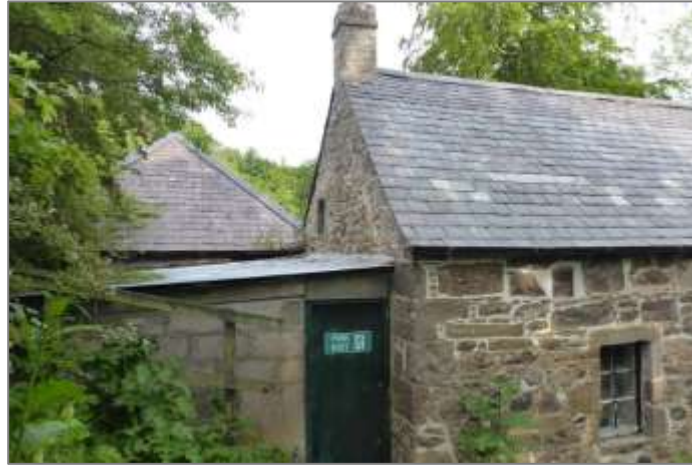
In the corner between the miller's house and byre is a small lean-to building constructed of exposed concrete block with a shallow corrugated roof. The design, quality and condition of this building is very poor. The failure of its junctions to the abutting masonry walls is causing water ingress and damp conditions and mould internally to both the kitchen extension and the shop/store. Damp conditions are present next to the electrical distribution box. The interior has no windows, and lacks ventilation.

*View of the kitchen extension abutting the miller's house and byre.*

- **Urgent action:** Investigate roof/wall flashings on the kitchen extension and make temporary repair.
- **Urgent action:** Undertake a structural assessment of the retaining rear wall and banking to facilitate removal of the extension and any retaining works required to maintain the mill pond embankment.
- **Necessary action:** Modern kitchen extension should be removed, following structural ground inspection, and the original masonry external walls assessed for repair and removal of any modern paint finishes.
- **Necessary / desirable action:** consider if the extension is required, and if so, design a more suitable one.

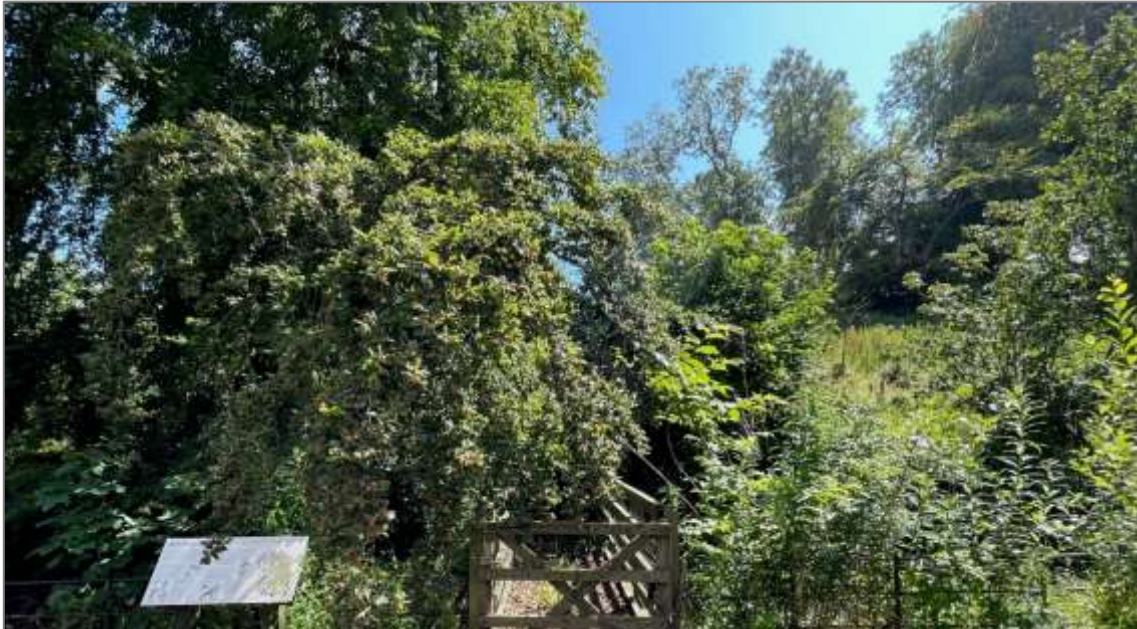
*View to the Mill Brae Wood from the mill courtyard with interpretation board; the footbridge to the woodland paths is currently locked for safety reasons.*

- **Urgent action:** clear principal footpaths and ensure any bridges across ditches are fit for purpose.
- **Necessary action:** upgrade paths, in an appropriate surface material in keeping with the woodland character and biodiversity.
- **Necessary action:** tree replanting and maintenance under appropriate license and consents on a priority phased basis and in line with an adopted *Mill Brae Wood Management Plan*.
