## Mill of Benholm, Kincardineshire, Aberdeenshire

**Gazetteer: Part 1: Mill Buildings**

# Version 2 November 2023

Prepared by Sonya Linskaill RIAS RIBA  
[slinskaill@btinternet.com](mailto:slinskaill@btinternet.com)

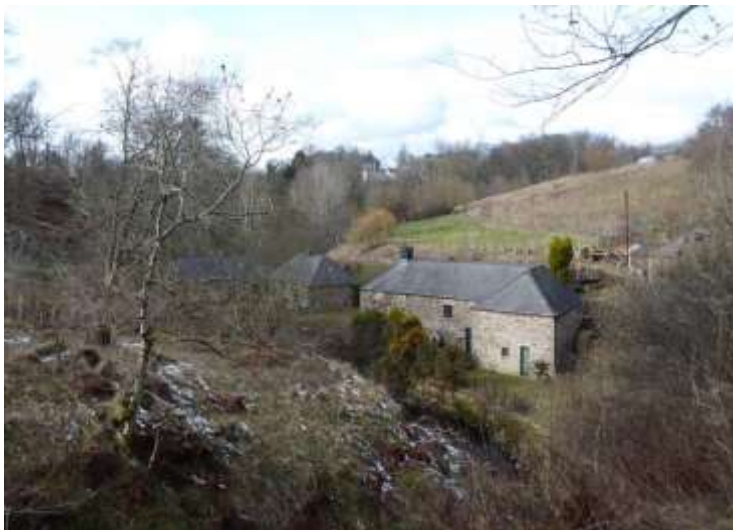
General view of the mill complex with meal mill in the foreground, 2023.

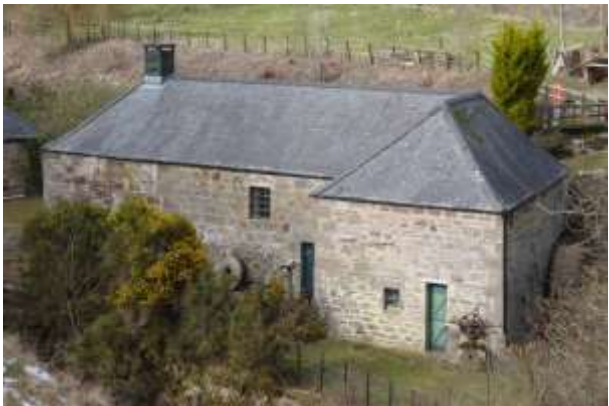
Building / elevation	Description & Images		Authenticity, Significance and Observations
<p><b>Meal Mill</b></p>

<p>2-storey L-plan stone built meal mill. The sloping site creates single storey north elevation with 2–storey south elevation on the riverside. Waterwheel on east elevation. Kiln abutted to west side forming extension to earlier building. Welsh slate roof with concrete ridges. Cast iron rainwater goods. Cat-slide roof over entrance doors at upper level with lead flashing and slate haffits.</p>

<p>Timber louvered ventilator over kiln with flat roof. Masonry construction indicates further building phases / historic development (described below). Timber fixed pane glazing in a number of fenestration patterns. Timber braced and vertically boarded doors.</p>	<p>As an example of a traditional water-powered meal mill, Benholm is of high significance, being one of only seven grain mills known to be operable or with the potential to demonstrate the milling process in Scotland. Refer conservation plan section 8.3.</p> <p>Evidence of possibly 4 building phases.</p>

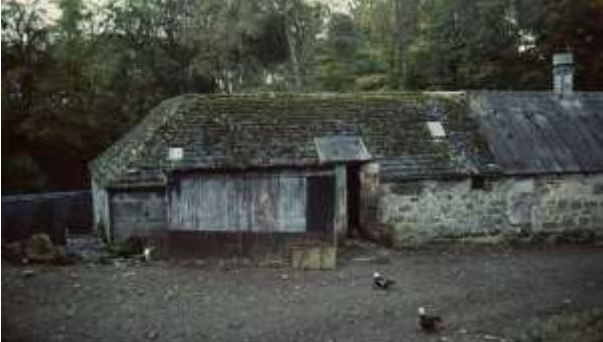
<p>Similar view in 1983 prior to adaptation. Note the heavy stone slate roof with mitred hip junction and skylights. © Mills Archive Trust: JWN collection image 10751: <a href="https://millsarchive.org/Benholm2-Images-and-documents">Benholm2 - Images and documents (millsarchive.org)</a></p>	<p>The current roof form appears from records to be as the original (notwithstanding extension of the building), however the Welsh slate finish and ridges are not.</p>

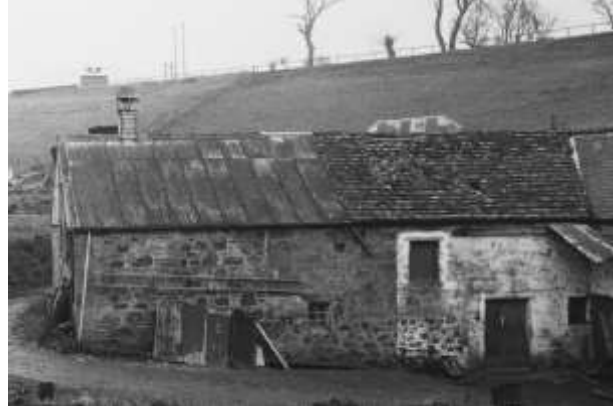
<p>South elevation in 1982 prior to adaptation. © HES under license, image B68973: <a href="https://canmore.org.uk/collection/2550726">https://canmore.org.uk/collection/2550726</a></p>	<p>The early masonry is of high significance.</p>

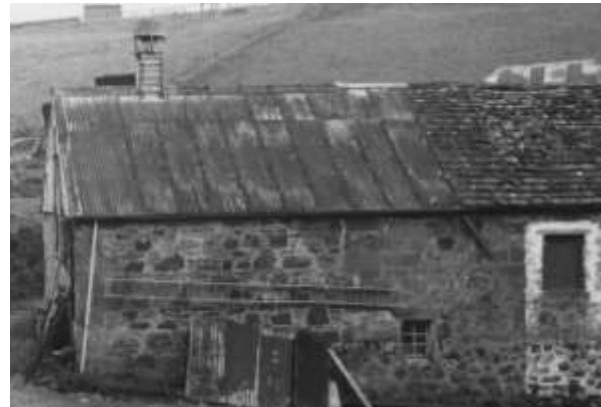
View in 1982 prior to adaptation. © HES under license, image B68973:

The corrugated sheet over the kiln roof with kiln ventilator of a different design were the result of a fire in 1971 after which the original slate and hipped end roof was replaced as above with a gable end and roof in asbestos sheeting.

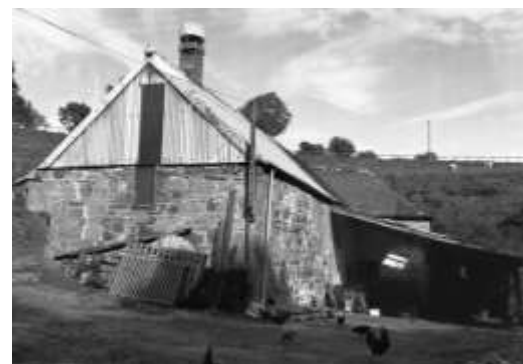
This image taken in 1974 shows that the opening was reduced during the adaptation with a new lintel inserted at a lower height to accommodate the new hipped roof construction. © HES under license, image SC444642:

The kiln is of high significance reflecting the development of local agriculture and the need for improved grain drying capacity. The masonry has undergone some repair and replacement but remains of high significance in the chronology of the meal mill's historic development.

The current roof form appears from records to be as the original, however the Welsh slate finish and ridges are not. The ventilator is of an inappropriate design and is discussed further in section 7.3.1 of the conservation plan.

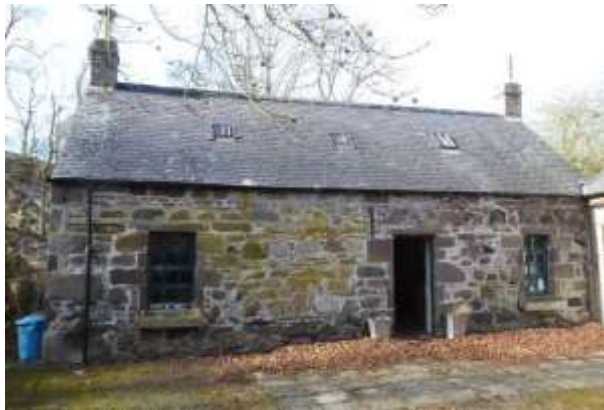
General view of east frontage facing the mill courtyard. The asymmetric frontage suggests the building may have differed in the past, possibly including a byre.

The miller's house displays similar build characteristics to the meal mill and could have early fabric remaining. It is possible it started as a traditional cottage and byre under one lower roof with later the roof raised to provide accommodation at attic level evident from the small gable windows.

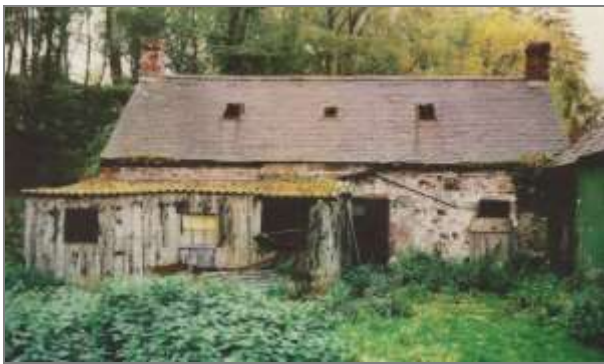
The miller's house in around 1986 note the timber and corrugated sheet extension probably added sometime from 1901 - 1923 (W&D DC postcard, © Aberdeenshire Council).

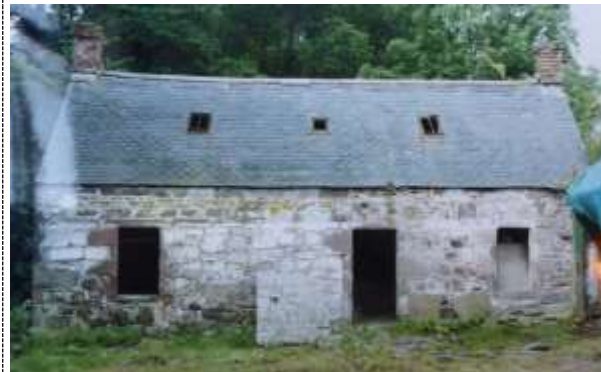
The miller's house in around 1992 just prior to repair and adaptation to a café. (HES file image, c.1992).

As with the meal mill, the nature of the stone masonry is significant in providing the chronology of the building development. Materially the external stone masonry underwent some repair during the adaptation (and repairs are clearly identified).

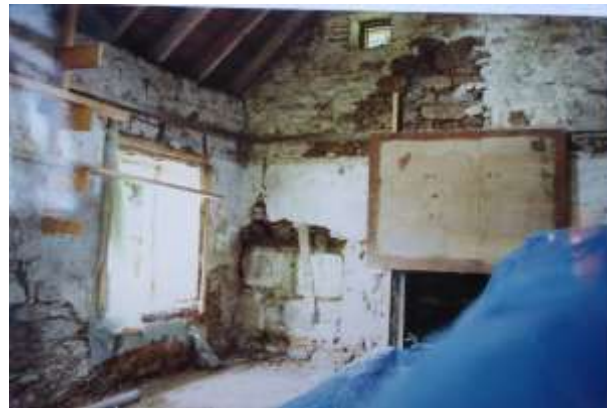
An image during adaptation shows the interior stripped back and the attic floor removed. The interior shows evidence of a possibly lower roof line showing as an unpainted part of the gable (HES file image, c. 1992).

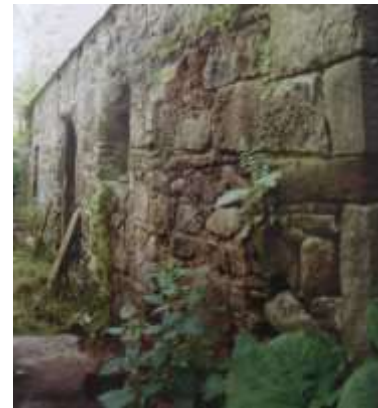
Photograph prior to the adaptation suggests the rear door was present prior to that, possibly roughly formed when the building was used as a byre (HES file image, c.1992)

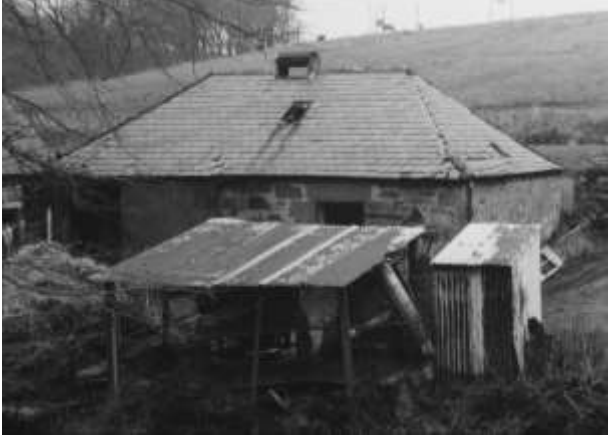
<p>View in 1982 of the byre prior to adaptation, note the original rooflight positions. © HES under license, image B68973: <a href="https://canmore.org.uk/collection/2550726">https://canmore.org.uk/collection/2550726</a> ).</p>

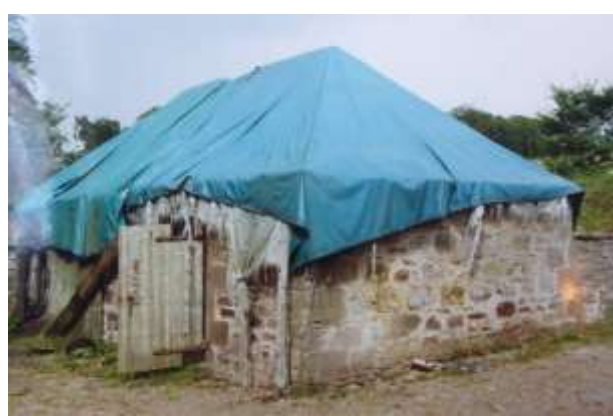
<p>Byre prior to adaptation, note the original cast iron door hinges which were retained (HES file image, c.1992).</p>	<p>The byre has most significance as part of the mill grouping and its position forming a loose courtyard with the miller's house. Its design significance is in the agricultural character of its frontage with a large sliding boarded timber door and the large door to the east with original cast iron hinges. It also reflects the crofting use of the mill lands by the miller and his family.</p>

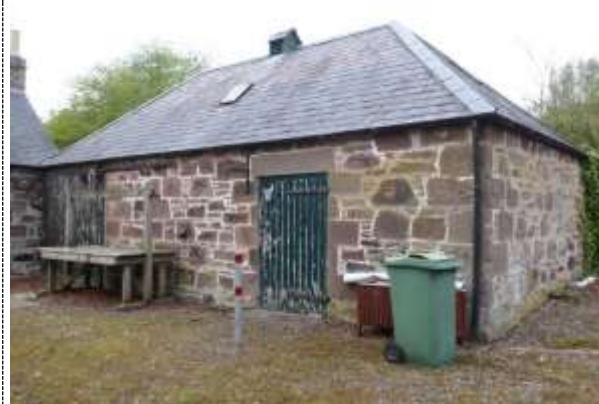
General view of showing the large boarded door. Iron handing bracket on LHS of door.

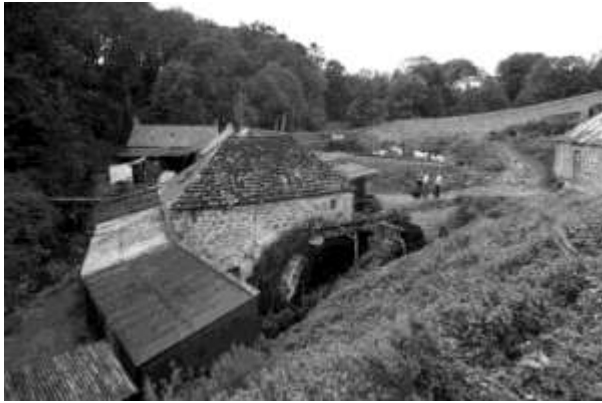
Mill of Benholm in 1970. Note the corrugated sheet roof over the grain store and no windows in the front elevation. Image ©Aberdeen Press & Journal, courtesy of MoBE.

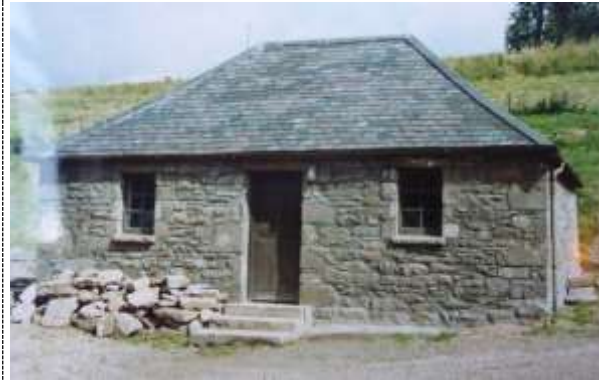
The grain store was one of the first buildings to be completed during the adaptation. It appears there was considerable reconstruction of the façade to introduce two windows and a central door. (HES file image, c.1992)
