Mill of Benholm, Kincardineshire, Aberdeenshire

Gazetteer: Part 2: Meal Mill Lower Floor

Version 2 November 2023

Prepared by Sonya Linskaill RIAS RIBA
slinskaill@btinternet.com

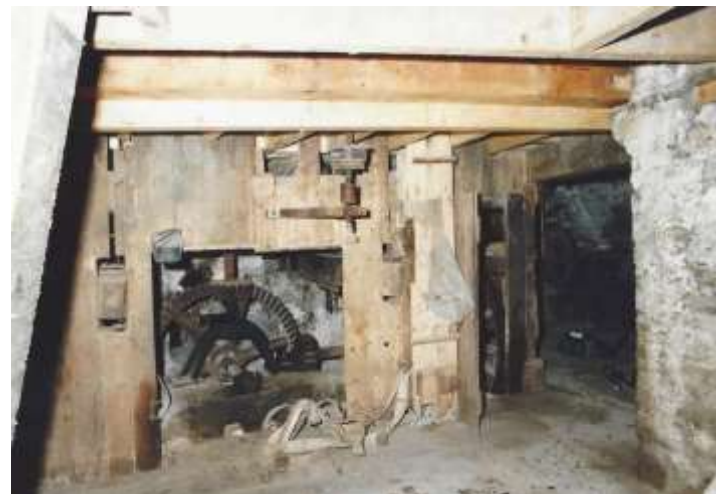
Similar view taken by WE Ltd during the restoration works. Part of the earlier timber **Gear Cupboard** has been cut away and the **Meal Sieve & Small Fanner** temporarily removed. Note the doors into the cupboard on the right – now removed.

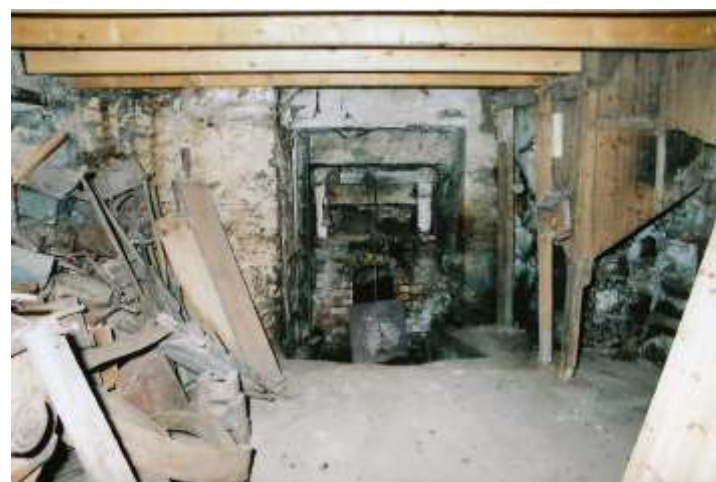
Similar view taken by WE Ltd during the restoration works. The kiln fire pit is visible with the **Kiln Chute** to the right. Note the new timber floor joists above.

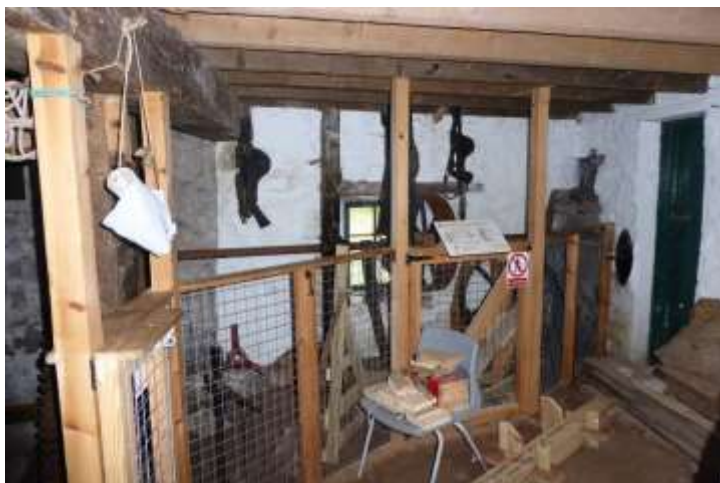
View of the southern extension in 2023. It is thought that the horse belts were brought to the mill by former custodian miller Pete Babs.

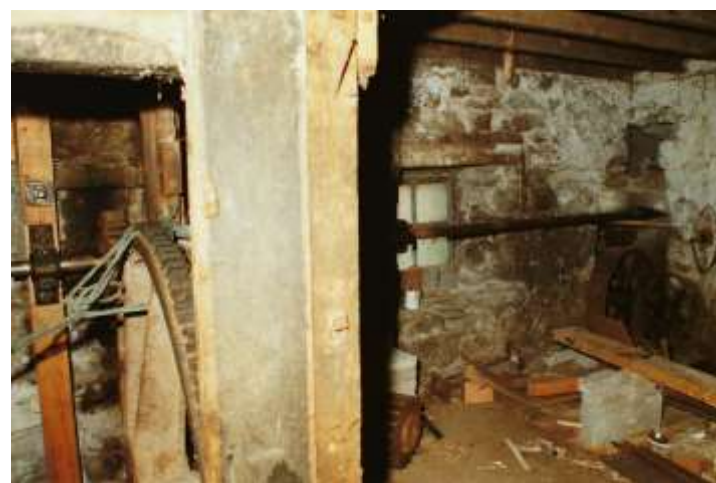
Similar view taken by WE Ltd during the restoration works. Note the **Auxiliary Spur Wheel** on the left, and its drive shaft behind already restored.

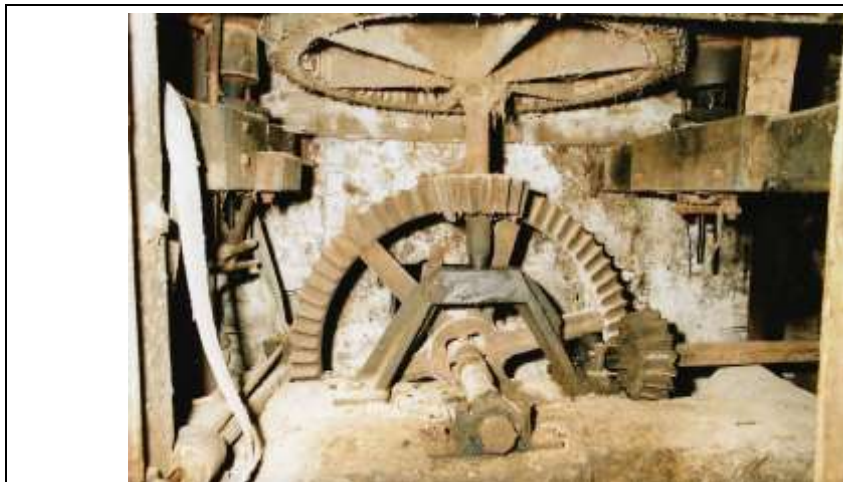
WE Ltd image (likely early 1991) before restoration works. Note the vertical **Pit Wheel** and the horizontal **Great Spur Wheel** above.

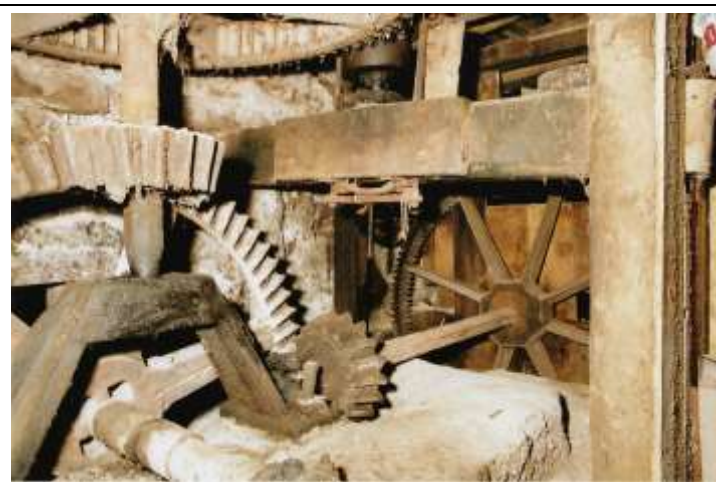
WE Ltd image (likely early 1991) before restoration works. Note the vertical **Pit Wheel** on the left and the vertical **Auxiliary Spur Wheel** on the right.

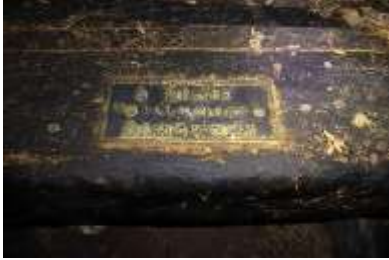
<p>Metal plate on timber base of Bruiser "A Milne Millwright Banchory".</p>	<p>Original hopper above Bruiser has been removed and floor infill panel visible.</p> <p>Former custodian miller Pete Babs confirmed the bruiser was not used during the building's use as a visitor centre.</p>
---	--	---	---	--

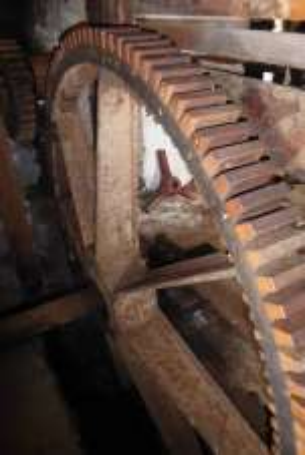
<p>Wooden cogs of the Auxiliary Spur Wheel. There's also a good during shot of wallower on WE sheet</p>	<p>Auxiliary Spur Wheel: oiled beech wood cogs are replacements handmade during the restoration by John Turner and WE Ltd (original worn). "W S & Son" on iron centre piece of spokes (on iron 8 spoke wheel; yellow numbering added for alignment); square shaft.</p> <p>The space on the south side of the Auxiliary Spur Wheel is enclosed. Metal oval plate and threaded rod adjacent to extension door.</p>

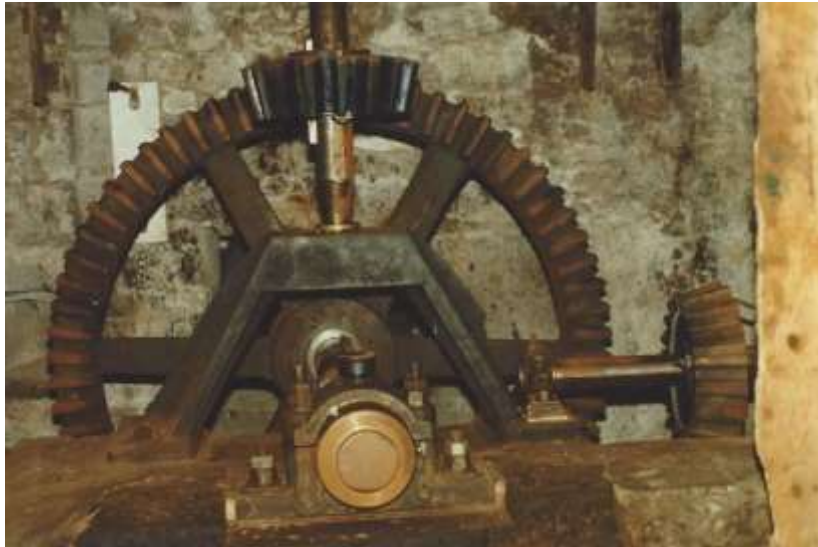
The **Pit Wheel** is operated by a horizontal steel axle from the **Waterwheel** and transfers power through a number of gears and drives to the milling apparatus. (WE Ltd image during restoration).

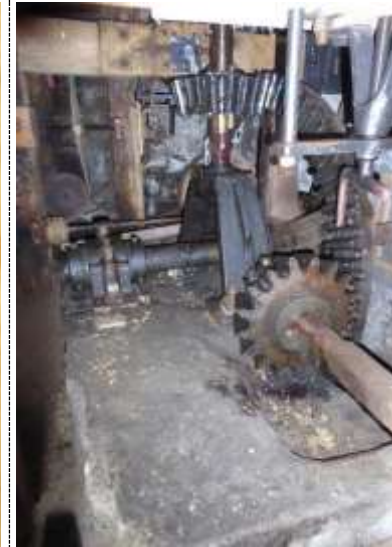
Wallowers at the top, and to the side of the **Pit Wheel** transfer its energy through drive shafts to the **Great Spur Wheel** and **Auxiliary Spur Wheel** respectively (not seen; Jack Ring just visible top-right).

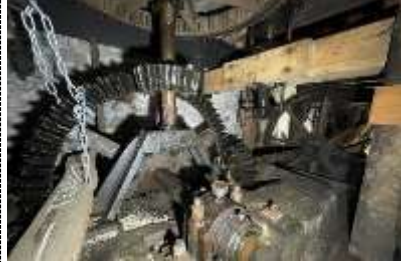
<p>View of the gear cupboard in 2023.</p>	<p>Note 2: The original intermediate bearing support had been patched over the years. To improve support and restraint for the waterwheel WE Ltd enlarged the hole, added a steel bed plate to provide firm support for the plummer block with cement consolidation of existing wall.</p>

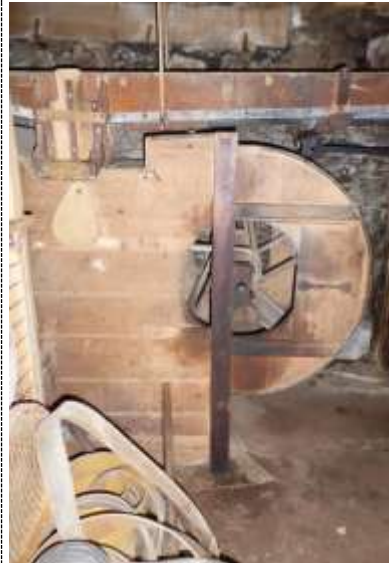
The **Shaker**, a long sieve, above the **Large Fanner**, note the internal paddles which create an air flow from the fanner.

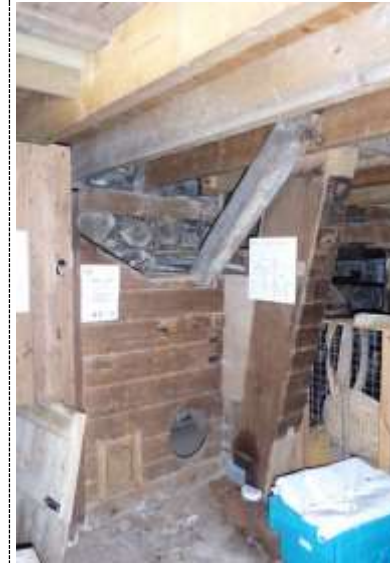
View of the **Large Fanner**. Groats are transported to the upper floor for grinding by the **Bucket Elevator**; unshelled oats are blown into a second hopper with an outlet at floor level (bottom left).

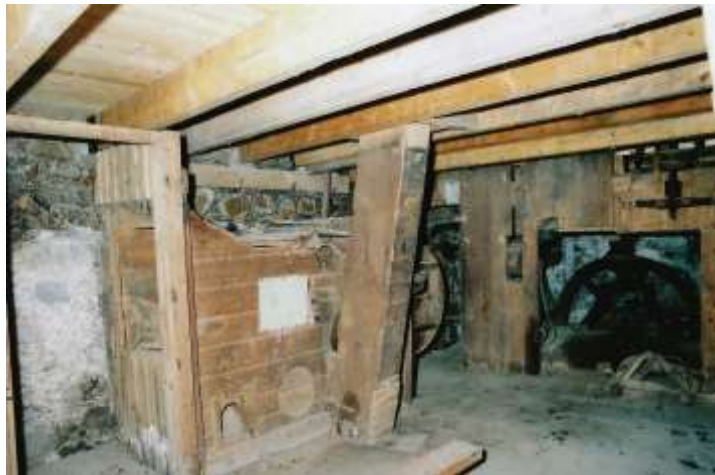
(Left) WE Ltd image (likely early 1991) before machinery restoration. The **Large Fanner** in the foreground and gear cupboard beyond.

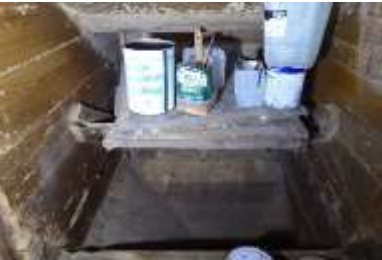
<p>View into the second hopper where unshelled oats were blown by the Large Fanner.</p>

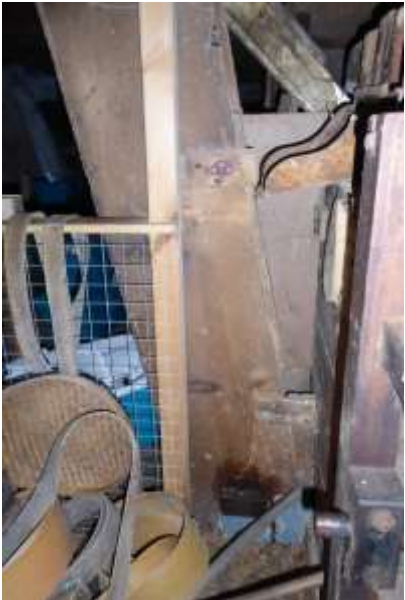
<p>Bucket Elevator encased in timber has metal cups (buckets) on a canvas felt in continuous flow taking Groats to the upper floor for discharge into bags. In the foreground the chute above the Large Fanner where dust is discharged from the Shaker sieve.</p>
--	--	--	--

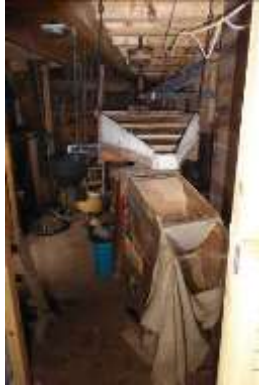
<p>Meal Mill Lower Floor Meal Sieve and Small Fanner</p>

<p>View from southern extension to Meal Sieve and Small Fanner.</p>

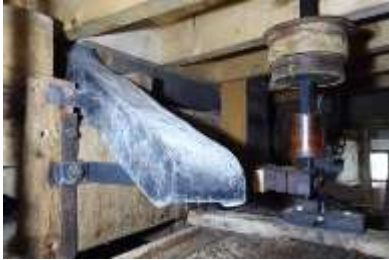
<p>Detail of metal spout through floor from Grinding Stones above to discharge onto the Meal Sieve, with crank shaft behind.</p>	<p>Used to separate oatmeal from unground groats and small husks from the grinding stones. A metal spout from the tun above deposits them onto a series of 4no. wire mesh sieves suspended from the ceiling above. The sieves sit into a wooden box, and are shaken by a crank shaft via a belt drive from the mill spindle. Oatmeal will fall through the sieves (which are used to grade the oatmeal) to a metal spout at the base of the box; a metal bagging funnel is suspended from the ceiling. Groats and large particles of meal travel to the end of the sieves and are fed into a small fanner via a large metal trough. They fall to the bottom of the fanner and from there are fed into the continuous-flow bucket elevator for the grinding stones which deposits them into the stones for a second time. Air flow pushes husks out of the end of the Small Fanner where they are bagged. Small fanner damaged including broken leg.</p>

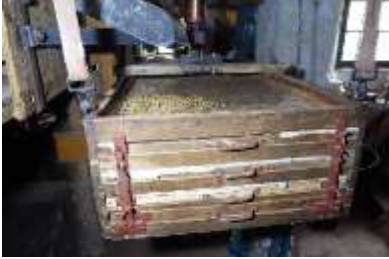
<p>Oatmeal grading sieve trays suspended in the Meal Sieve shaker.</p>

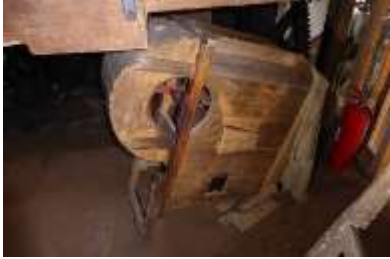
<p>Small Fanner that separates husks from groats and feeds groats into the continuous-flow bucket elevator to the grinding stones.</p>

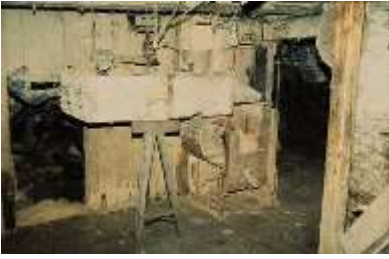
<p>View of the Meal Sieve & Small Fanner prior to dismantling for restoration. © Mills Archive Trust: Jim Woodward-Nutt, 1983, image 10743: https://catalogue.millsarchive.org/benholm-harp</p>	<p>“Oat meal sieve with small fanner at outlet end as well as outlet into (grinding) bucket elevator” recorded by Douglas (Canmore, 1983, MS/500/35/83). Considered to be original to the mill and of high significance.</p>

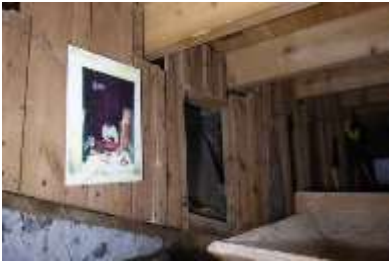
<p>Meal Mill Lower Floor Husk Cupboard</p>

<p>View of Husk Cupboard looking towards the Gear Cupboard.</p>

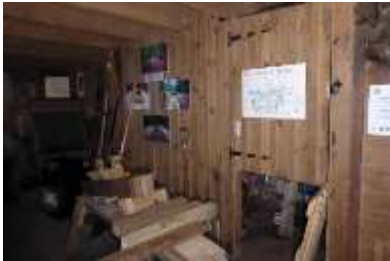
<p>View of Husk Cupboard looking towards the kiln area.</p>

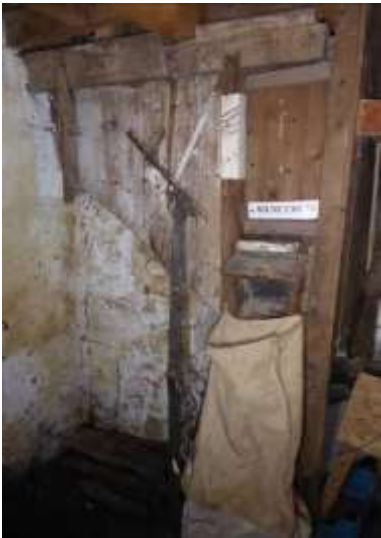
<p>Kiln Chute includes a hopper under the outlet from the kiln above.</p>

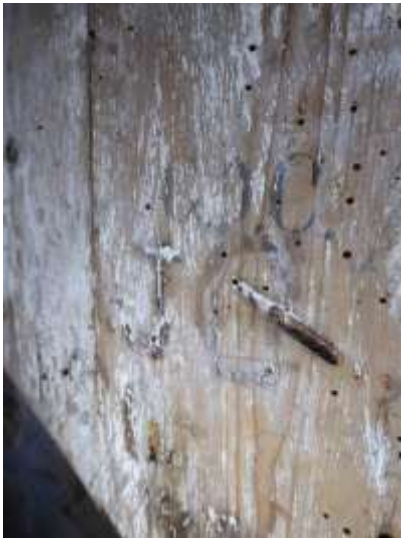
<p>Graffiti “G.D.C” and “J” on chute.</p>		<p>Also known as a “Bag Shot”</p>

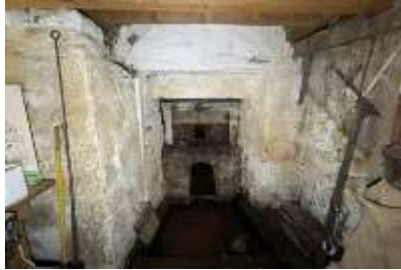
**Meal Mill Lower Floor
Kiln fire box with
damper**

General view of the **kiln fire box**.

Stepped stone structure thought to have been constructed against the earlier mill building. Evidence of dressed stone jamb margins and stone lintel suggesting former doorway / opening. Further lower stone lintel and walling to create fire box, infilled with brick to form arched fire box with damper above with cast iron door. Lower floor pit in front for ash.

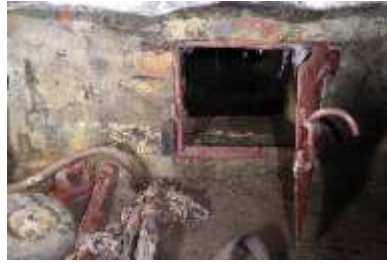
Kiln fire **damper**.

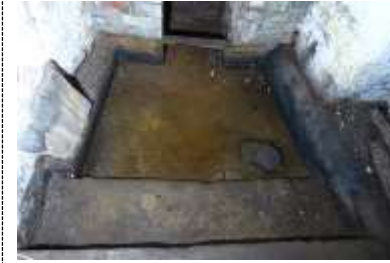
Shallow ash pit in front of the kiln fire box.

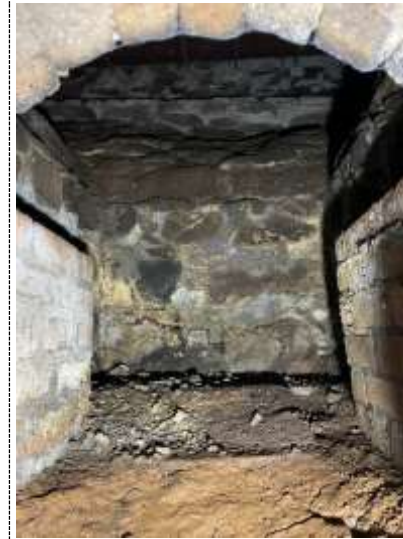
View into the fire pit showing the built up construction forming the funnel shape below the wire mesh floor above.
