Mill of Benholm, Kincardineshire, Aberdeenshire

Gazetteer: Part 3: Meal Mill Upper Floor & External Items

Version 2 November 2023

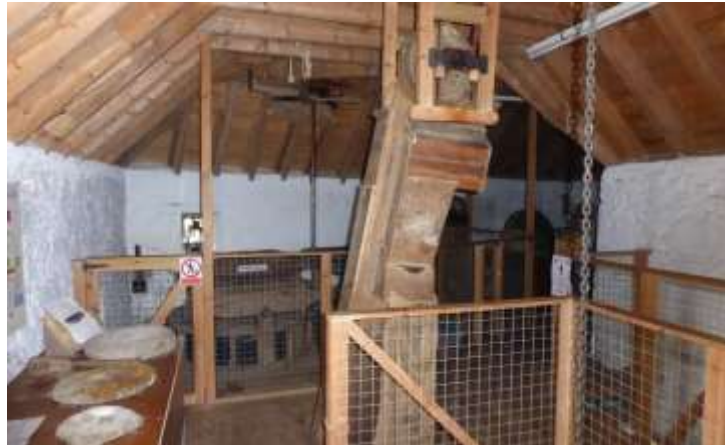
General view in 2023 looking east toward the **Shelling & Grinding Stones** with **Bag Hoist** and **Bucket Elevator** in the foreground.

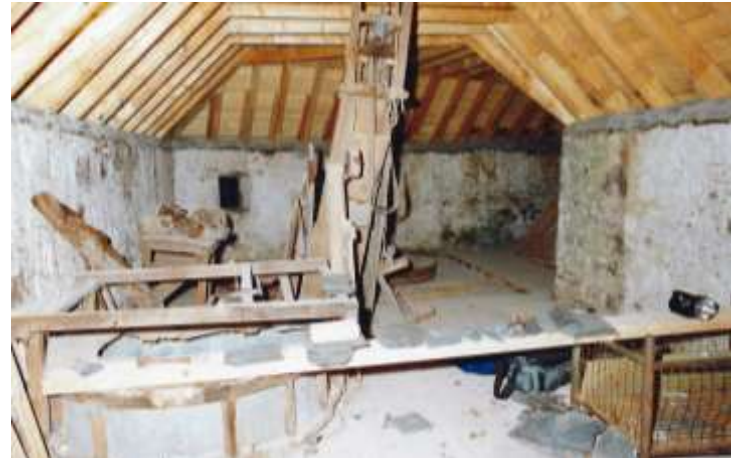
Similar view taken by WE Ltd during the restoration works, c 1991. **Bag Hoist** and **Bucket Elevator** prior to repair in the foreground, milling stone casing removed.

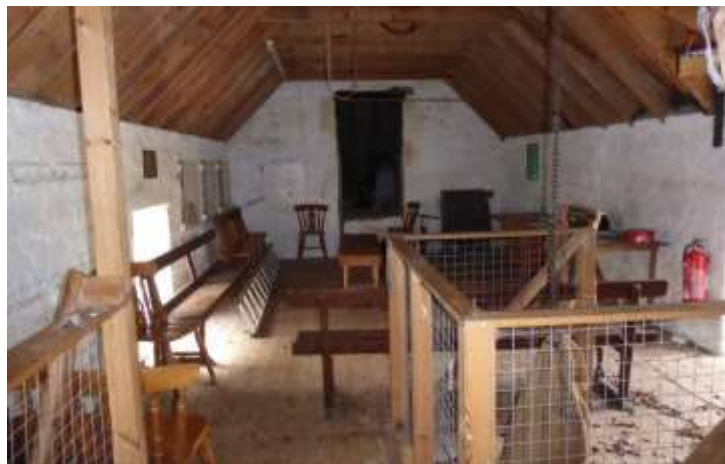
General view in 2023 looking west to the kiln.

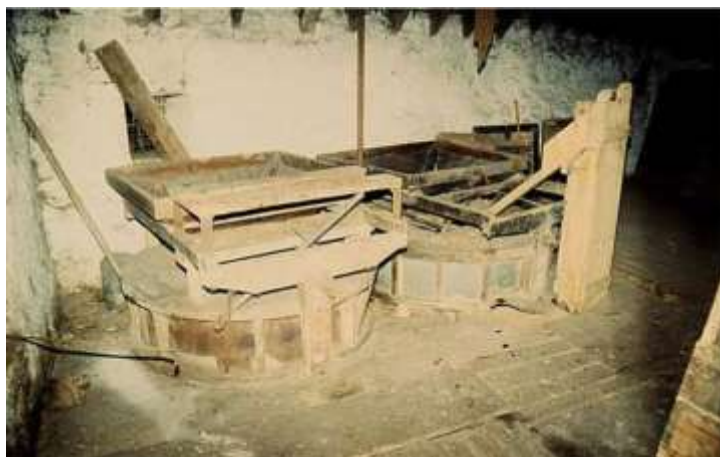
View of the millstones within their tuns and hoppers in place prior to restoration.
 © Mills Archive Trust: Jim Woodward-Nutt, 1983, image 10746:
<https://catalogue.millsarchive.org/benholm-st>

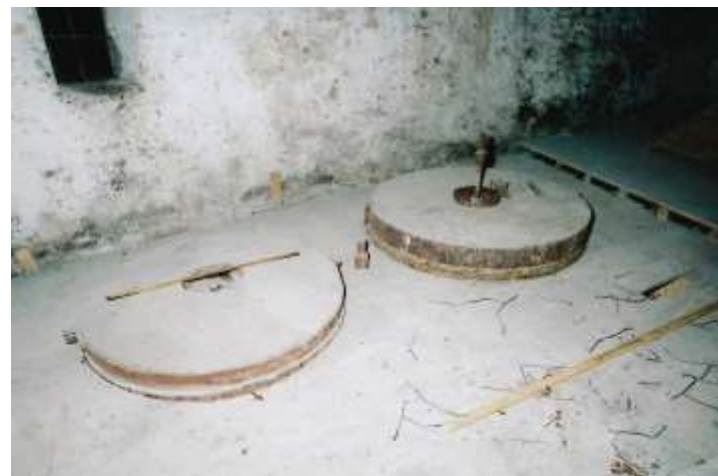
WE Ltd image during the restoration works, c.1991 with the milling stone equipment dismantled to allow repair and assessment of the stones left by the last miller.

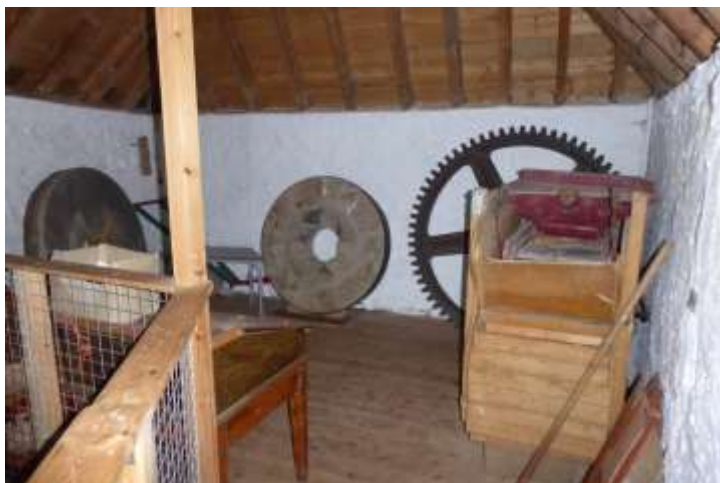
General view in 2023 of the southern extension area, now a display area. Compare to newspaper image below of miller Lindsay C Watson c.1970 with sack storage.

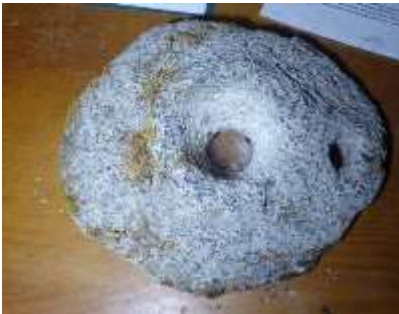
<p>Modern table with 3no. quern stones and timber /metal tool for turning quern stones. Loose information sheets.</p>

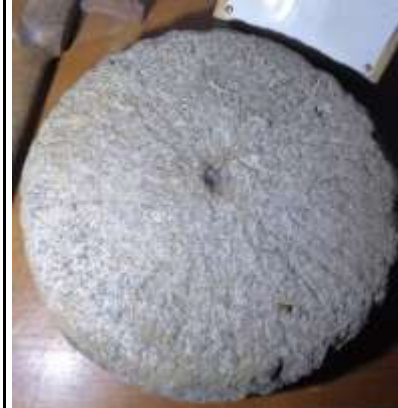
<p>Quern stones would have been used for hand milling and not associated with the current water mill. It's possible these stones were collected from near the site / or local area to form a display. Not significant for the water mill context. P. Babs commented that the querns weren't there when initially a visitor centre.</p>
<p>Meal Mill: Upper Floor Shelling Stones and Grinding Stones with small Bucket Elevator</p>

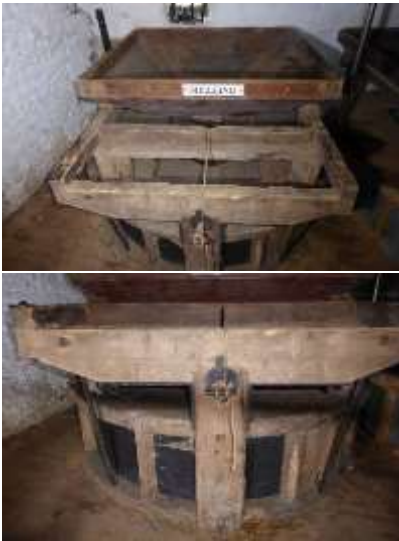
<p>The Shelling Stones set within their timber tun with hopper above. Recorded in 1983 as "monolithic 120cm dia" (47"; Canmore, MS/500/35/83)</p>

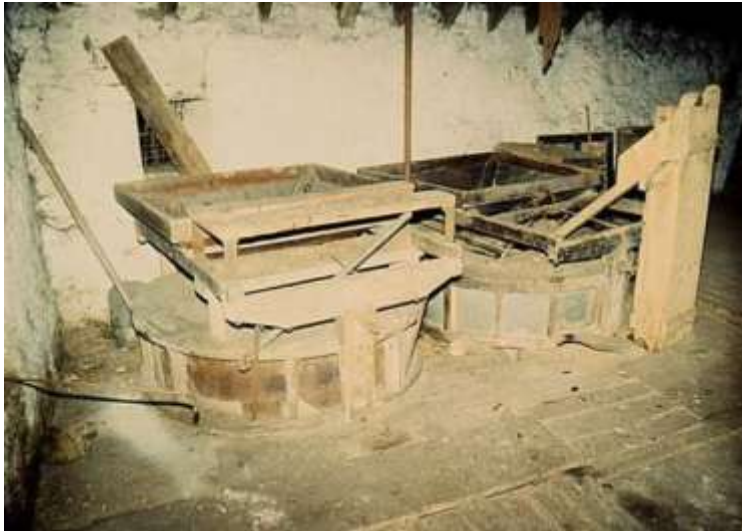
<p>View of milling stones prior to restoration with the Shelling Stones on the left. Note original floor and also in foreground left is the earlier lever through the small opening to operate the sluice on the Trowse (note 2). © Mills Archive Trust: Jim Woodward-Nutt, 1983, image 10746: https://catalogue.millsarchive.org/benholm-st</p>	<p>From interpretation panel: 2no. monolithic gritstones, refaced with carborundum. 1 set of 2 stones: stationary bed stone with runner stone above rotated (anticlockwise) by mill spindle. Stones sit within a wooden casing (the tun). Above timber hopper with tilted wooden tray (shoe) which directs grain into 'eye' of the stone. The 'damsel' and ash tensioning stick shake the shoe to ensure a steady flow of grain. Kernels, husks and meal dust are caught by the tun and 2 metal scrapers directs this to outlet chute to lower floor to be separated in the Shaker & Large Fanner.</p>

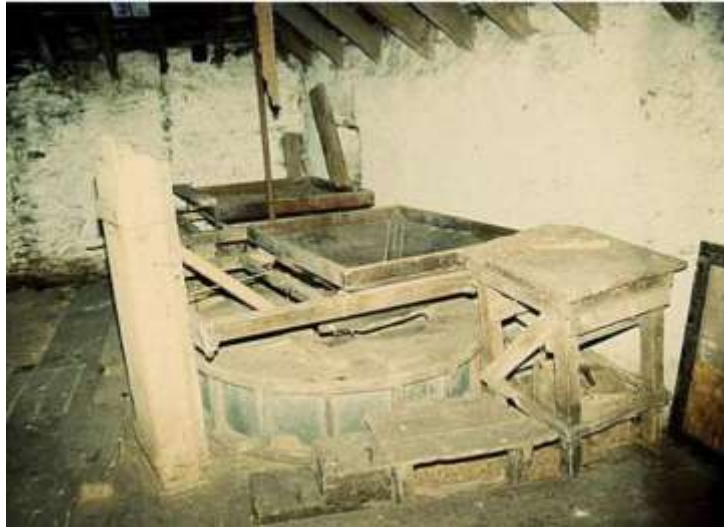
View of milling stones with the **Grinding Stones** in the foreground prior to adaptation. Note the earlier wooden steps for access to hopper not retained during restoration. © Mills Archive Trust: Jim Woodward-Nutt, 1983, collection image 10747: <https://catalogue.millsarchive.org/benholm-st2>

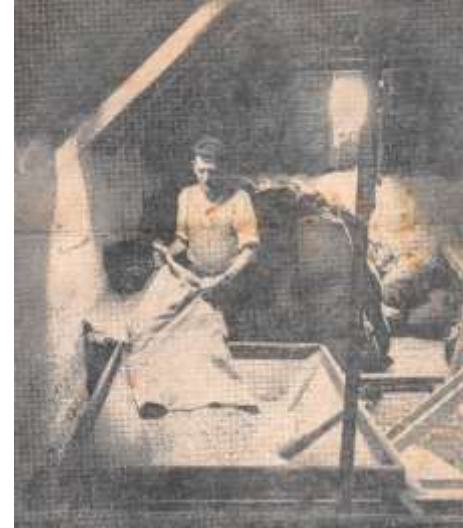
Newspaper image from c.1970 of Lindsay C Watson, the last commercial miller, filling the hopper over the **Grinding Stones**, with sacks behind in the southern extension. Image courtesy of JHH, source not known.

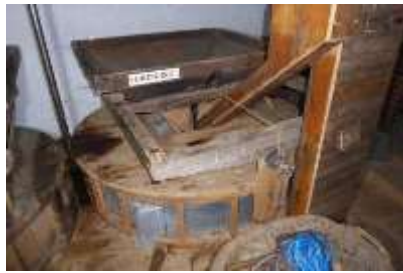
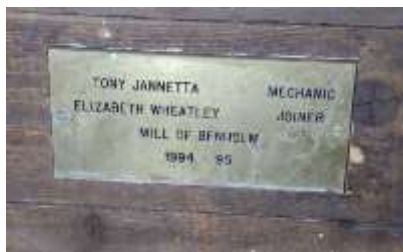
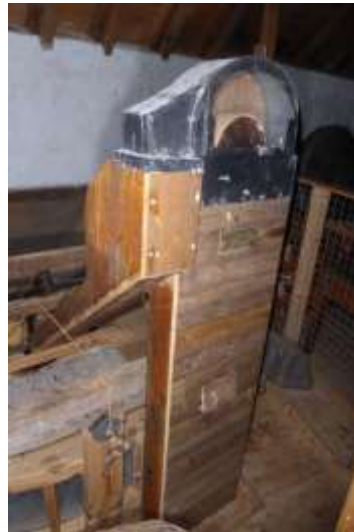
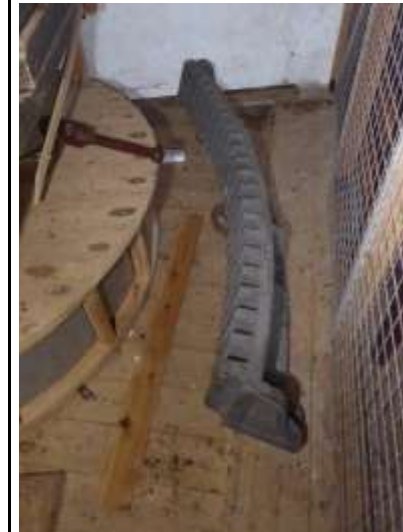
The **Grinding Stones** consist of 1 pair of 2 stones: Burr stones segments and hub pieces formed held in position by cast iron band. The grinding stones were recorded in 1983 as "burr-stone 140cm dia." (Canmore, MS/500/35/83).

The inscription "City Mills Perth 1906" can be seen in the coating on the underside of lower grinding stone.

<p>(Top) The Grinding Stones set within their timber tun with hopper above and feed chute from the Bucket Elevator.</p> <p>(Below) Brass plaque on the Bucket Elevator with "Tony Jannetta Mechanic" "Elizabeth Wheatley Joiner" "Mill of Benholm 1994-95" Responsible for the restoration of the secondary machinery.</p>	<p>Bucket Elevator from the Meal Sieve and Small Fanner which discharges unground Groats back into the grinding stones for a further time.</p>	<p>Piece of wooden cogged formwork.</p>	
<p>Meal Mill: Upper Floor Display Area</p>

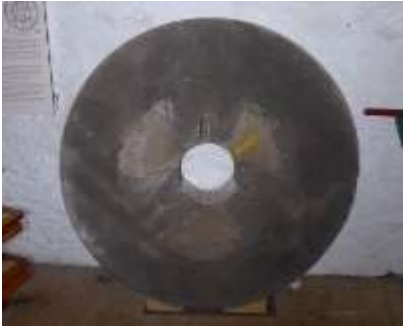
<p>Large shelling stone ('husk stone' written on side) 131cm (51½"); possibly from Benholm, as a monolithic stone appears in BBC footage in 1971 outside the mill.</p>	  <p>10-piece milling burr stone with cement covered hub 122cm (48") dia. held by cast iron band.</p>

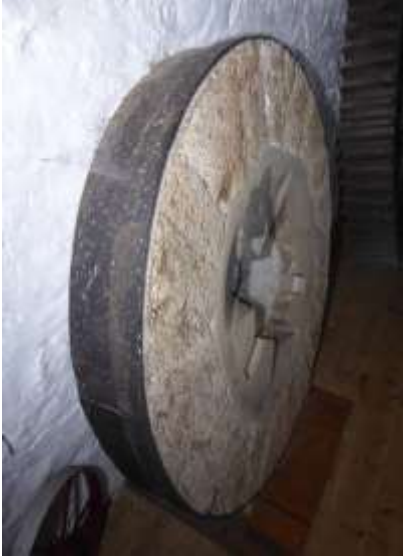
<p>View of milling burr stone cast iron band 165mm (6½") wide with 12" hub.</p>	<p>The burr stone is thought to be half of one pair with the burr stone of the same size outside the mill. Refer Conservation Plan section 7.9.</p>

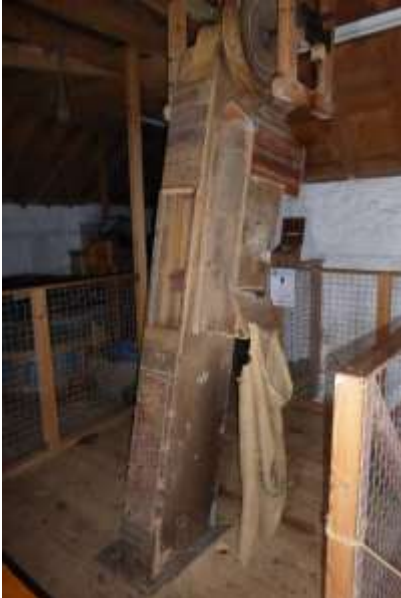
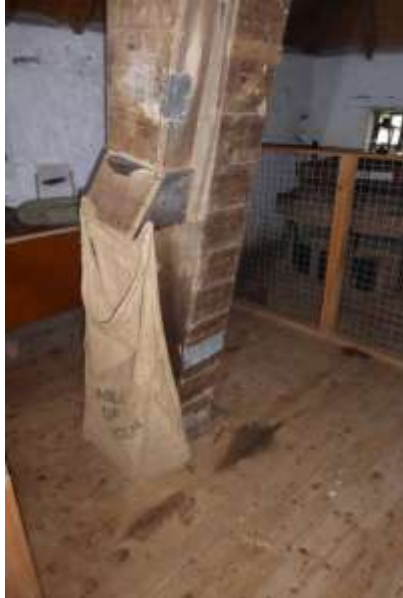
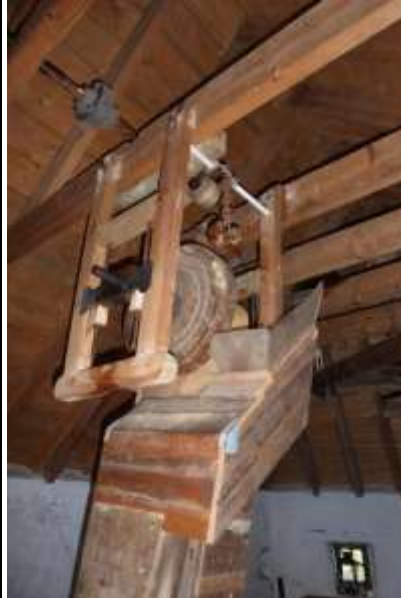
<p>Meal Mill: Upper Floor Bucket Elevator</p>

<p>The Bucket Elevator gearing is powered by the main shaft from the water wheel which runs through the Great Spur Wheel to drive the Bag Hoist and Bucket Elevator through mitre gears at roof level.</p>	
<p>Bag Hoist and Trap Door</p>

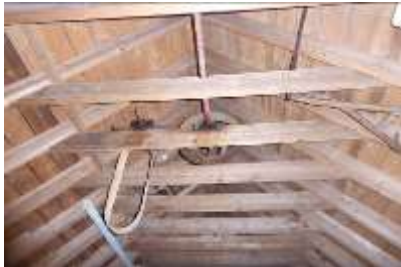
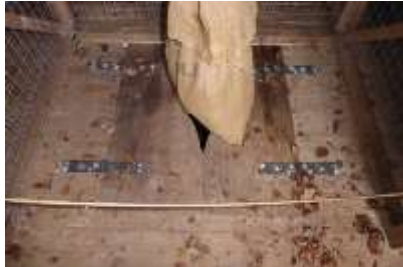
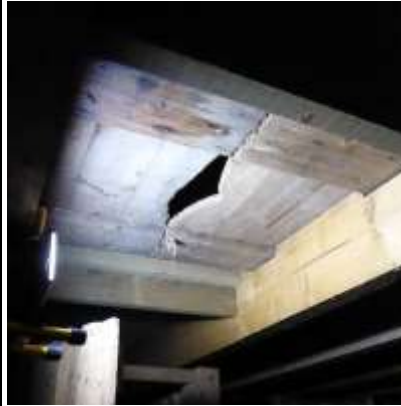
<p>Friction driven hoist to lift sacks of oats from the lower floor for processing in the Shelling Stones Trap door recorded as 75cm sq in 1983 and drawing indicates orientation of doors were at 90 degrees to current position (Canmore, GJD survey, 1983).</p>	
<p>This Bucket Elevator carries Groats which have passed through the Shelling Stones into the Shaker & Large Fanner (lower floor) ready to be ground.</p>	<p>The Groats discharge to bags at the Bucket Elevator to be manually handled to the Grinding Stones hopper.</p>	<p>View of the Bucket Elevator gearing.</p>	<p>View of roof space in upper floor with gearing for the Bag Hoist.</p>	<p>Trap door in the new upper floor.</p>	<p>View of trap door from below.</p>

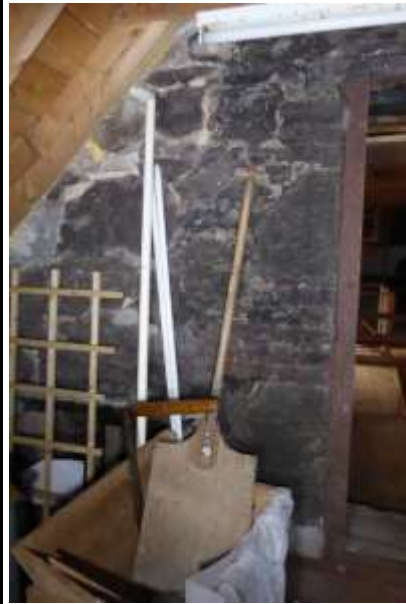
View of the internal wall (opening to kiln outlet chute is behind stored items).

Large amount of miscellaneous items and furniture stored in the kiln which could overload the floor and damage the mesh. Restricted assessment of walls and floor.

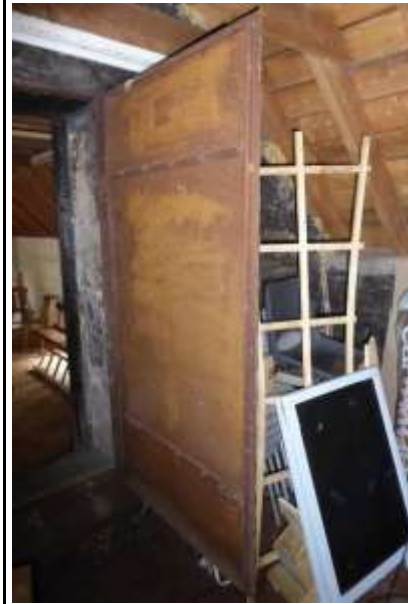
View of the external metal door face from inside the kiln.

The kiln door may have been an earlier opening in the gable wall of the earlier mill configuration – large jamb stones and stone cill could suggest this, however also brick infill at jambs. Timber lintels suggest some age.

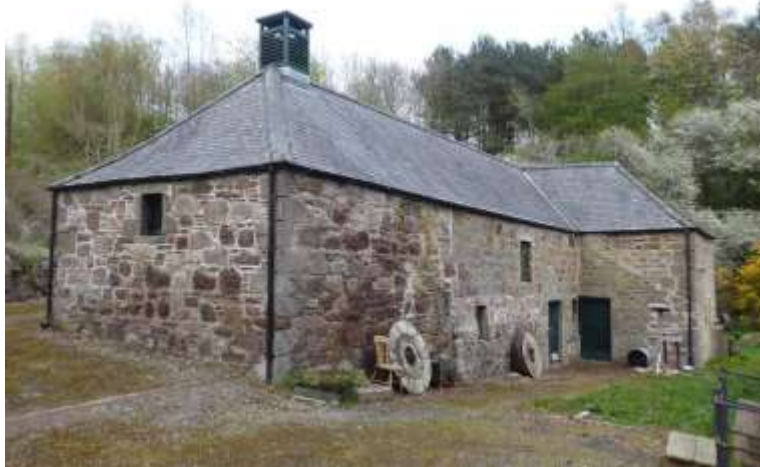
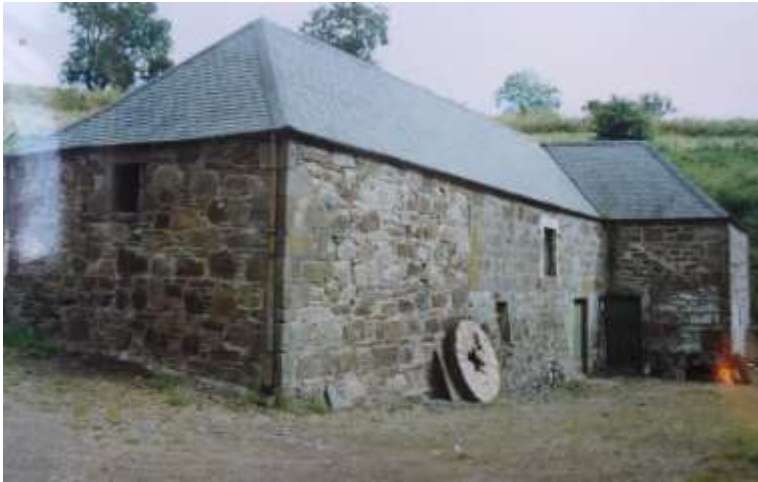
<p>General view of the south elevation of the meal mill building 2 milling stones in 2023.</p>	<p>Same view in early 1990s during adaptation with the 23-piece burr stone (HES file image, c.1992).</p>

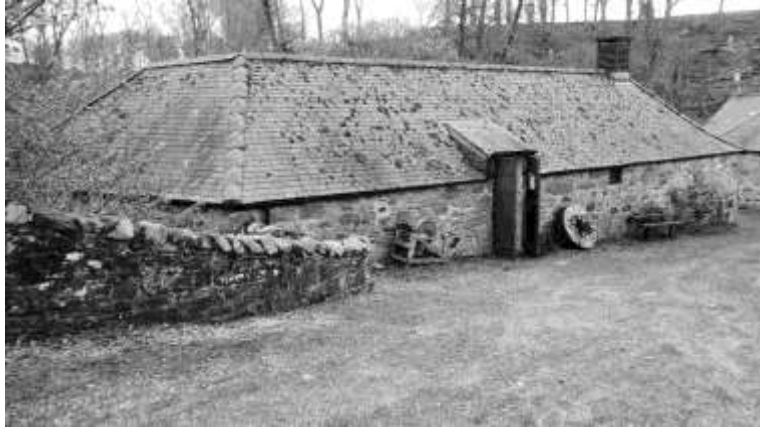
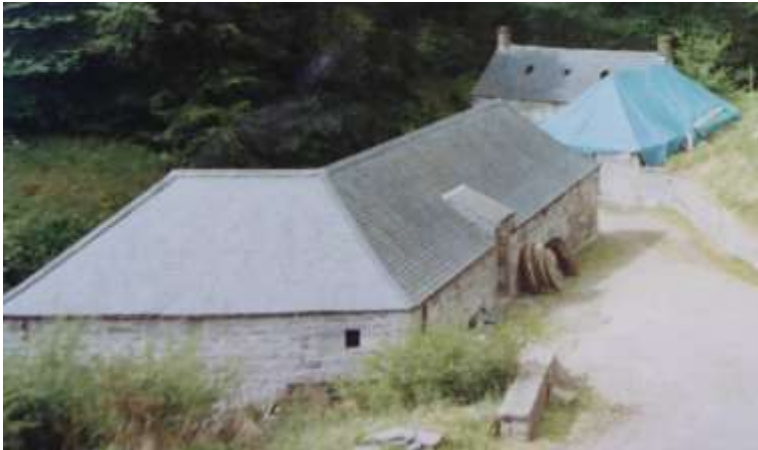
<p>General view of the north elevation of the mill building with 1 milling stone in 2023</p>	<p>Same view in early 1990s during adaptation with 3 milling stones (HES file image, c.1992).</p>

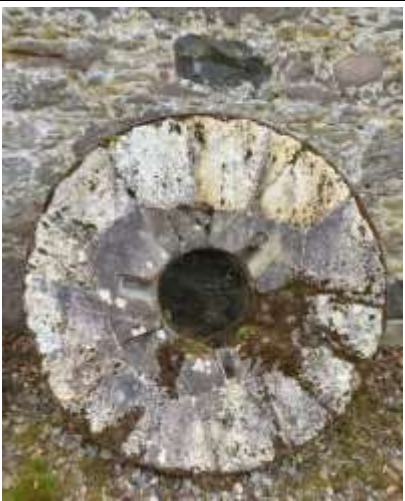
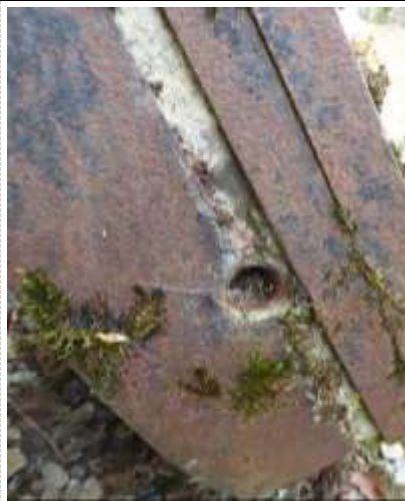
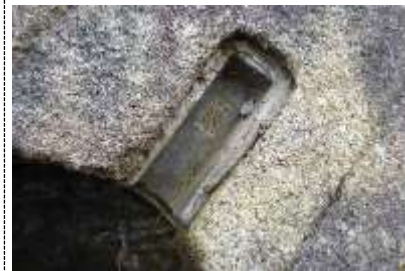
<p>Meal Mill North elevation: Grinding stone</p>

<p data-bbox="443 1324 846 1425">Burr stones and cast iron band 43" dia. x 9 3/4 " thick, 12" centre, 14 segments</p>		<p data-bbox="1682 805 2094 941">This stone is thought to be half of one pair from Cowie Mill, Stonehaven. Refer Conservation Plan section 7.9.</p>

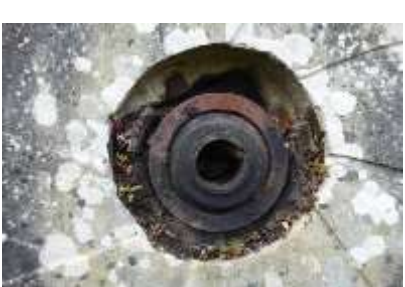
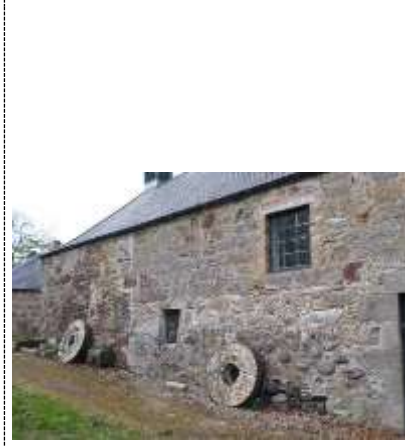
<p>This stone is thought to be half of one pair with the burr stone in the display area. Refer Conservation Plan section 7.9.</p>
	<p>Burr stones and cast iron band 48½" dia. x 6" thick, 12" centre with 8½" hub, 13 segments.</p>		<p>View of the 2 milling stones of south elevation.</p>
