Mill of Benholm, Kincardineshire, Aberdeenshire

Gazetteer: Part 4: Water Mill Infrastructure

Version 2 November 2023

Part 4: Water Mill Infrastructure

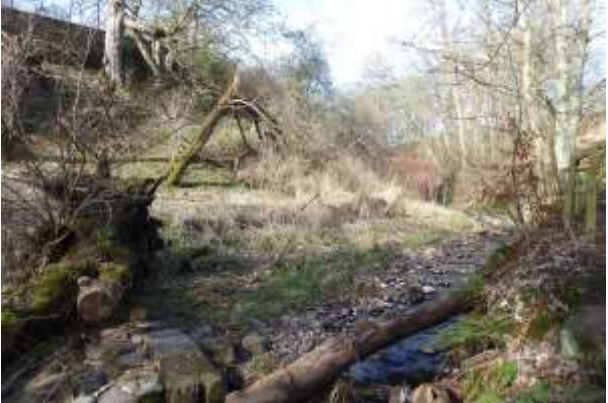
<p>The primary water source for the mill is the Castle Burn seen here looking north from the Lower Weir at the head of the lade.</p>

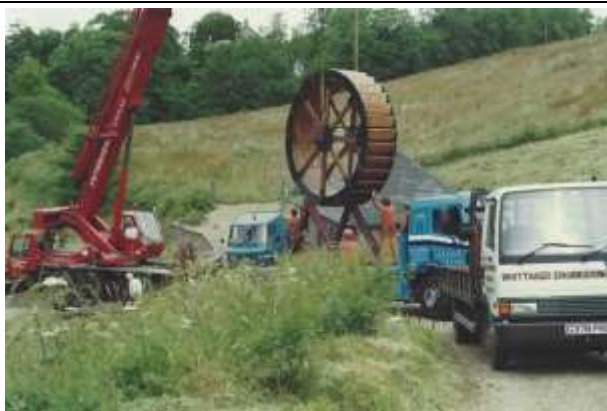
WE Ltd delivering the new waterwheel for installation in April 1992 (WE Ltd image).
